SAND AUDITING IN NEYYAR RIVER

Report

The Neyyar River in southern Kerala has been taken for the river sand auditing programme as per the directions given by State High Level Committee for River Management, Dept. of Revenue, Govt. of Kerala.

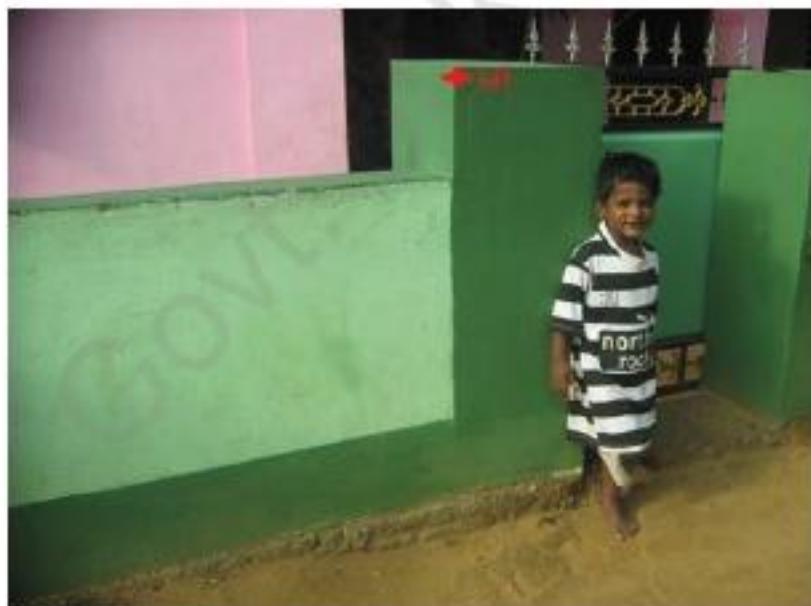
PROFILE - 1
KALLIKKAD GRAMA PANCHAYAT
TBM: Top part of compound wall on the right bank

This river cross-section has taken 120 m downstream of Neyyar reservoir bridge . The bench mark here is top part of compound wall of a house on the right bank (House No.157, Canan Foundation) which falls in the 4th ward of Kallikkad Gramapanchayat of Nedumangd Takuk.

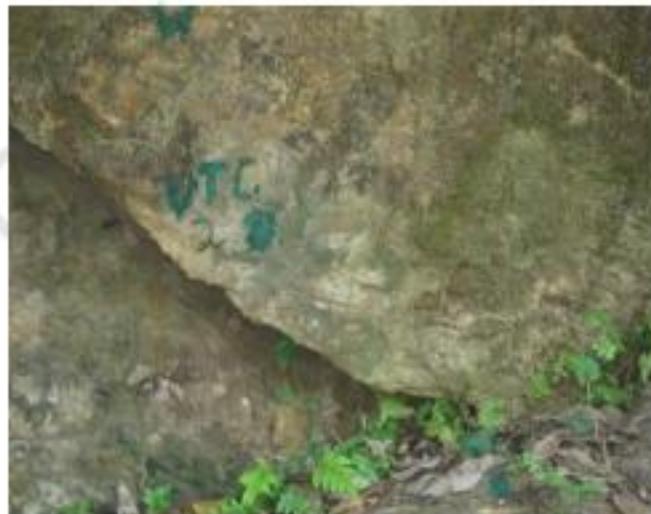
PROFILE - 2
KALLIKKAD GRAMA PANCHAYAT
TBM: Rock exposure on the right bank

The present river cross-section has taken 500 m downstream of Neyyar Reservoir Bridge. The bench mark of this profile is on a rock exposure which falls in the Kallikkad ward of Kallikkad grama panchayat on the right bank of Neyyar river. A poultry farm is found on the way to the river on the right bank.

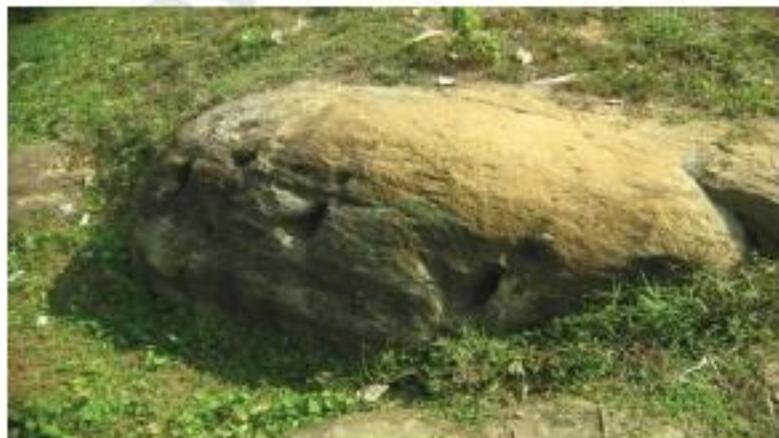
PROFILE - 3
KALLIKAD GRAMA PANCHAYAT
TBM: Rock Exposure on the right bank at Mannadimoola Kadavu

The current river cross-section has taken from Mannadikadu which is 720 m downstream of Neyyar Reservoir Bridge. The bench mark of the present profile is on a rock exposure which falls in the Kallikkad ward of Kallikkad grama panchayat on the right bank of Neyyar river.

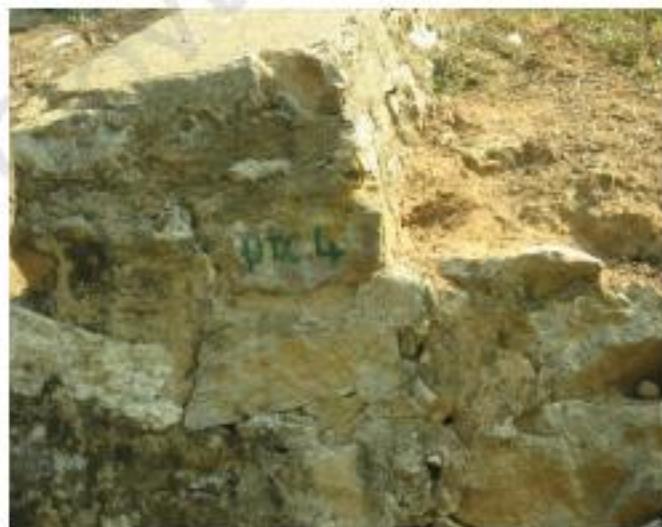
PROFILE - 4
KALLIKKAD GRAMA PANCHAYAT
TBM: Side wall on the right bank at Perinjam kadavu

This river cross-section has taken from Perinjankaduvu . The bench mark of the present profile is on the sidewall of Perinjankadavu which falls in the Perinjankadavu ward of Kallikkad gram panchayat on the right bank of Neyyar river.

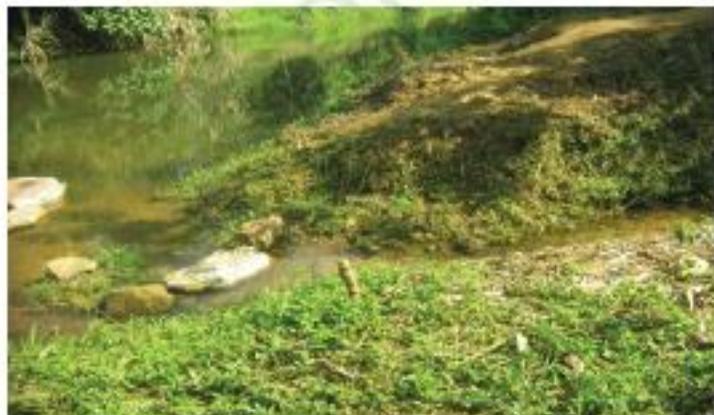
PROFILE - 5
KALLIKKAD GRAMA PANCHAYAT
TBM: Cherinjam Thode joins on the left bank

The present river cross-section has taken from Cherinjankonam kadvu . The bench mark of the present profile is the meeting point of Cherinjankonam thodu to the Neyyar River on the left bank. The benchmark falls in the Mailakkara ward of Kallikkadu Gramapanchayat.

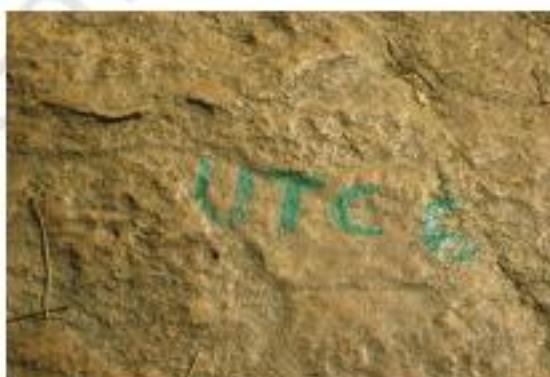
PROFILE - 6
KALLIKKAD GRAMA PANCHAYAT
TBM: Rock Exposure on the right bank at Pazhayakottapuram

The present river cross-section has taken 80 m north of Kallikkad Bridge. The bench mark of the present profile is on a rock exposure at pazhayakottappuram of Kallikkadu Gramapanchayat on the right bank.

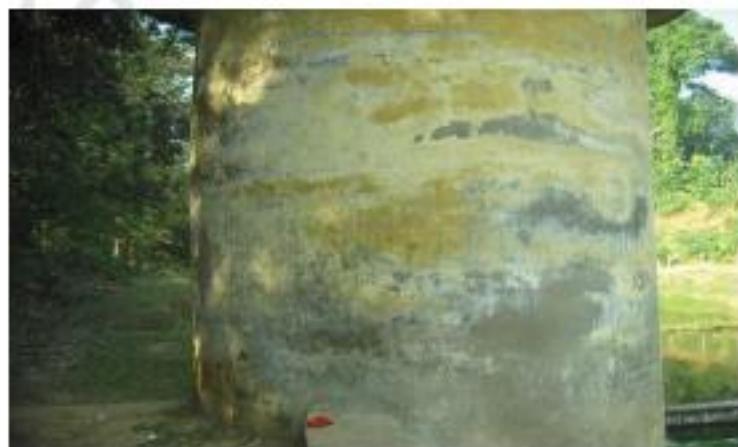
PROFILE - 7
KALLIKKAD GRAMA PANCHAYAT
TBM: KWA Water tank on the left bank at Mailakkara

This river cross-section has taken 340 m south of Kallikkad Bridge. The bench mark of the present profile is on the water tank of Kerala Water Authority which falls in the Mailakkara ward of Kallikkad grama panchayat on the left bank of Neyyar river. A check dam is also found across the river.

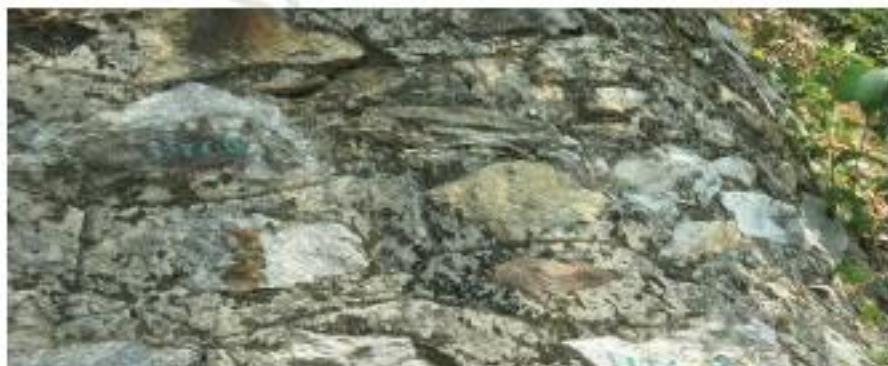
PROFILE - 8
POOVACHAL GRAMA PANCHAYAT
TBM: Top part of side wall constructed on the right bank at Therikkannadikadavu

This river cross-section has taken from Therikkamannadi kadavu of Poovachal Panchayat. The bench mark of the present profile is at the edge of sidewall of kadavu on the right bank of Neyyar River. A small unmetalled road is joins with the river on the right bank.

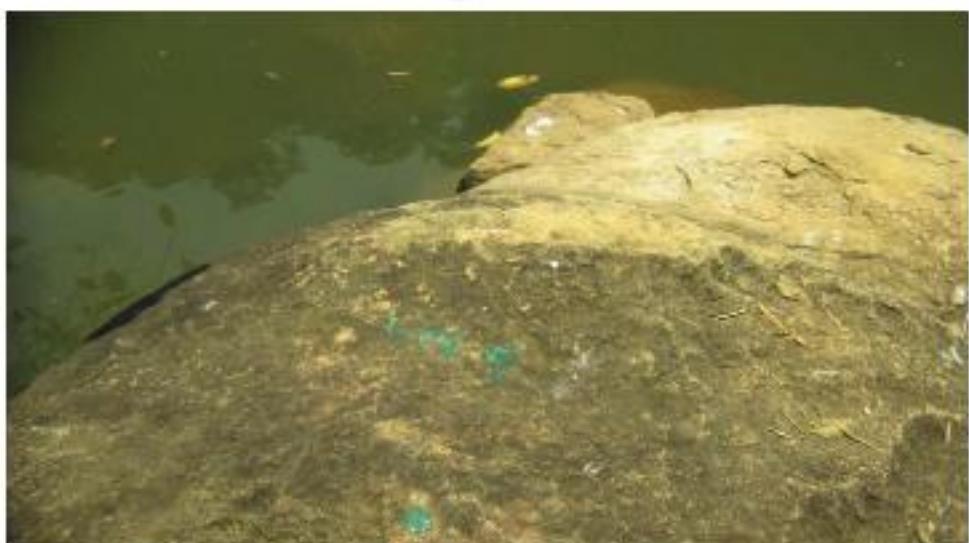
PROFILE - 9
POOVACHAL GRAMA PANCHAYAT
TBM: Rock Exposure on the right bank at Thalayadichampara

This river cross-section has taken from Thalayaichampara of Poovachal Panchayat. The bench mark of the current profile on a rock exposure on the right bank of Neyyar River. A bricklin is found on the right bank.

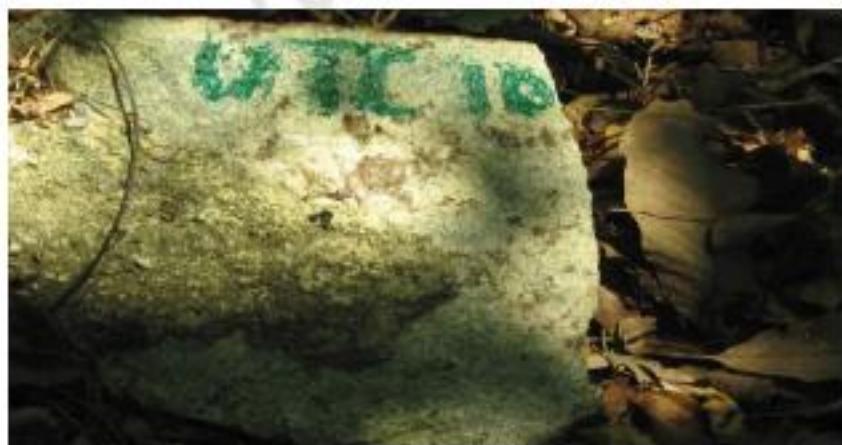
PROFILE - 10
POOVACHAL GRAMA PANCHAYAT
TBM: Road joining Kollaru Kadavu on the right bank

This river cross-section has taken from Kollaru Kadavu of Poovachal Panchayat. The bench mark of the current profile is on a stone on the road side at right bank of Neyyar River. A small road to Veeranakavu from the Kadavu is found.

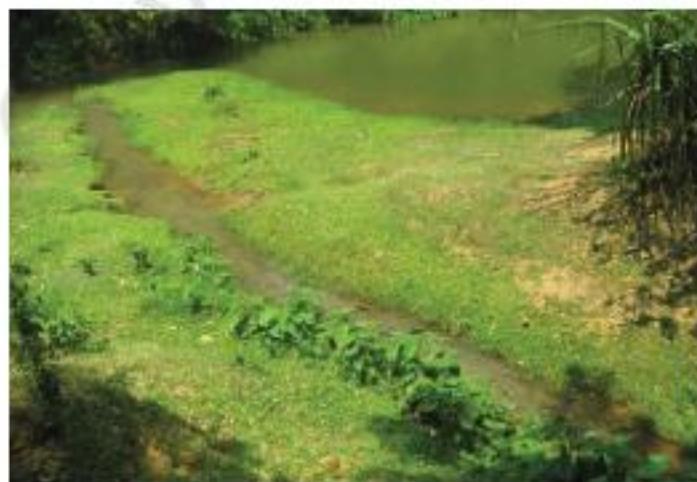
PROFILE - 11
KALLIKKAD GRAMA PANCHAYAT
TBM: Mullawinmoodu Thode joining on the left bank

This river cross-section has taken from 10 north of Mullilavinmoodu thodu which joins Neyyar on left bank. Mullilavinmoodu thodu is the boundary of Kallikkad panchayat and Ottasekharamangalam panchayat Panchayat is taken as the benchmark and is 150 m north of kolangaramoozhi kadavu.

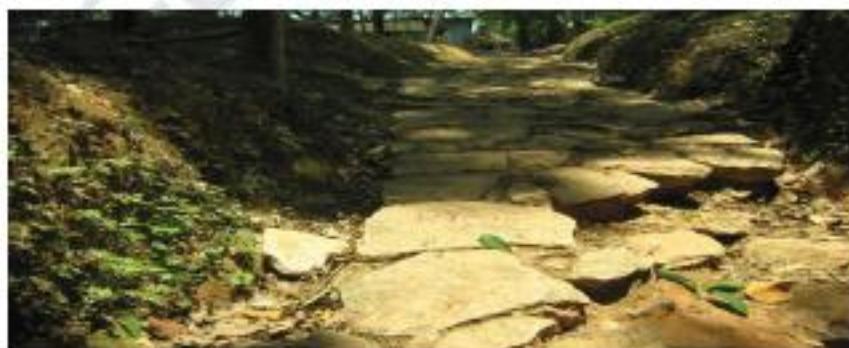
This river cross-section has taken from Kolangaramoozhi kadavu of Kadambara ward in Ottasekharamangalam panchayat. The road joins the Kolangaramoozhi kadavu on the left bank is taken as the benchmark. The present river cross-section is 150 m south of Mullilavinmoodu thodu.

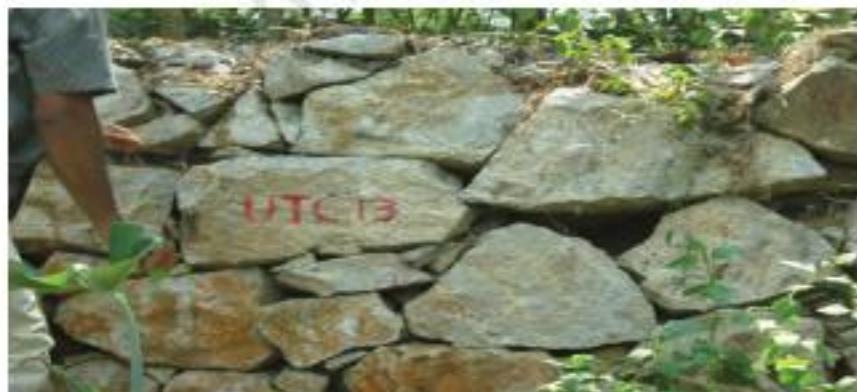
PROFILE - 13
POOVACHAL GRAMA PANCHAYAT
TBM: Side wall on the right bank at Mannidjanmoola Kadavu

This river cross-section has taken from Mannidijanmoola kadvu. The bench mark of the present profile is on the side wall of rubber plantation on the right bank which falls in the Chaikulam ward of Poovachal panchayat.river. Rock exposure is found both in the river and its bank.

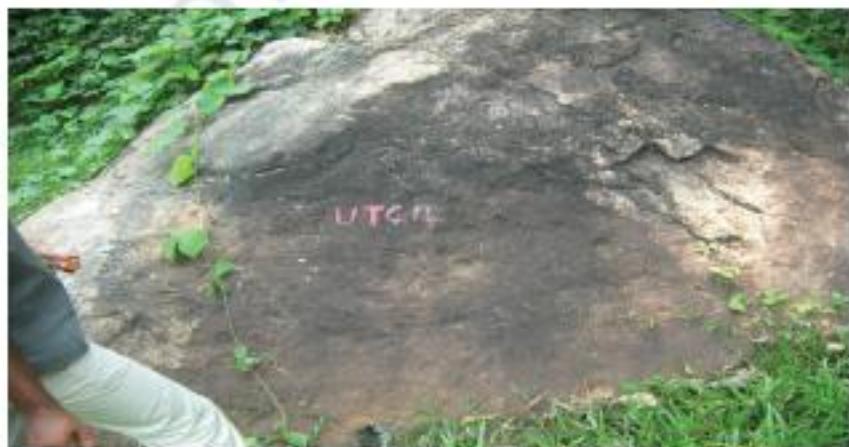
PROFILE - 14
POOVACHAL GRAMA PANCHAYAT
TBM: Rock exposure on the right bank at Thenguvila Kadavu

This river cross-section has taken from Thengivila Kadavu . The bench mark of this profile is on rock exposure on the right bank of the river. The benchmark of the current profile which falls in the Chaikulam ward of Poovachal panchayat.river

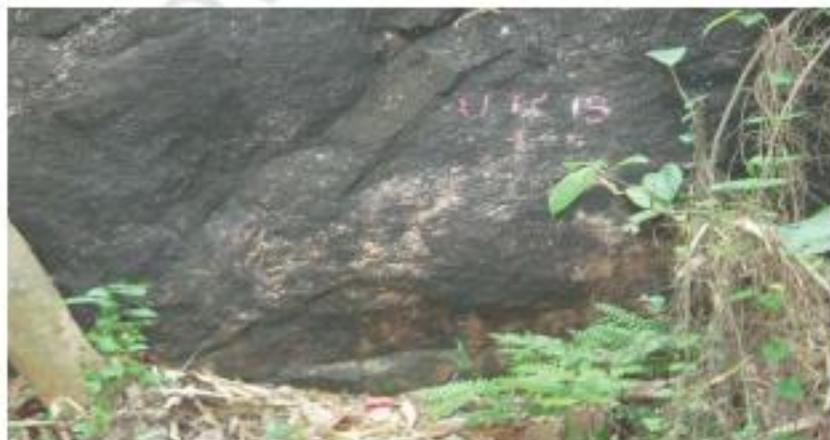
PROFILE - 15
POOVACHAL GRAMA PANCHAYAT
TBM: Rock exposure on the right bank

This river cross-section has taken from Keppai Kadavu . The bench mark of this profile is on rock exposure on the right bank of the river. The benchmark of the current profile which falls in the Chaikulam ward of Poovachal panchayat. It lies between $08^{\circ}30'20.9''$ N latitude and $077^{\circ}07'104.9.''$ E longitude.

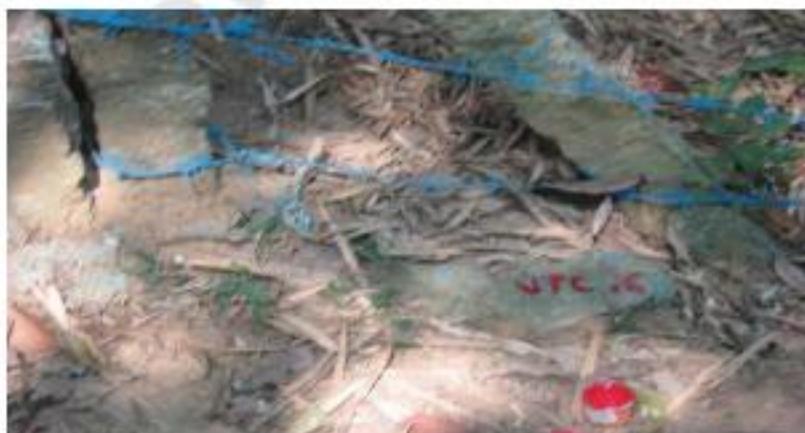
PROFILE - 16
KATTAKKADA GRAMA PANCHAYAT
TBM: Survey stone on the right bank

This river cross-section has taken from Kudimutti Kadavu . The bench mark of the profile is on a survey stone on the right bank of the river. The benchmark of the current profile which falls in the Kattakkada Panchayat. It lies between $08^{\circ}30' 03.8''$ N latitude and $077^{\circ}07' 06.60.''$ E longitude.

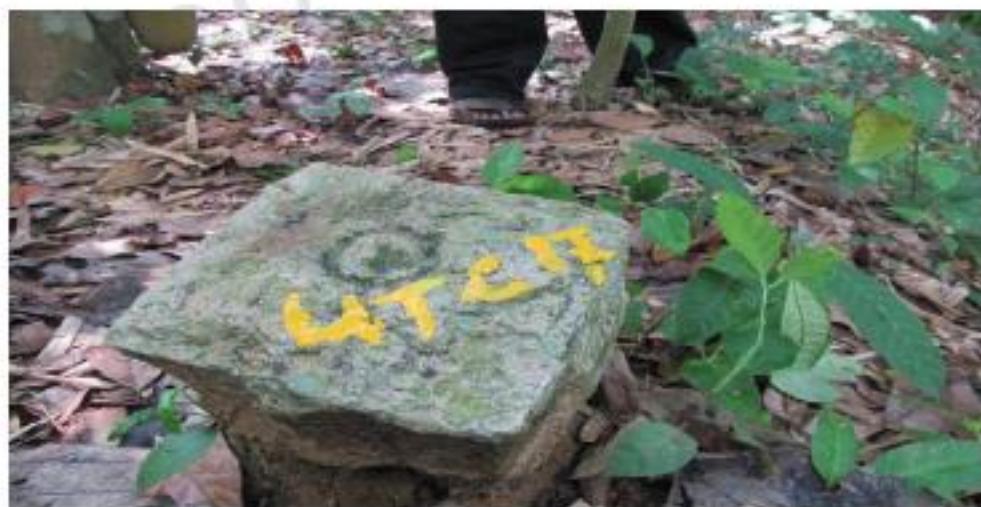
PROFILE - 17
KATTAKKADA GRAMA PANCHAYAT
TBM: Survey Stone on the Right Bank

The present river cross section has taken Thevarucoil. A survey stone close the left bank of the tributary is taken as bench mark. The benchmark falls at the Chandramangalam ward of Kattakkada Panchayat. It lies between $08^{\circ} 29' 49.6''$ N latitude and $077^{\circ} 07' 09.8''$ E longitude.

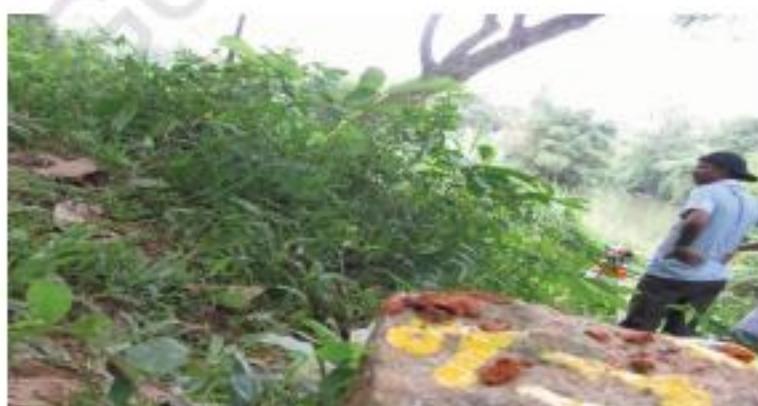
PROFILE - 18
KATTATTAKKADA GRAMA PANCHAYAT
TBM: Survey Stone Near Tributary Joining at the Right Bank

The present river cross-section falls at a tributary meeting point of Neyyar on the right bank .This cross-section is 8095.8m downstream of Neyyartadam and lies between 08°29'41.8'' N latitude and 077°07'03.7'' E longitude .The Bench mark is on surveystone at the right bank of the river close to the left bank of the tributary.The takes a sharp bend in this point.

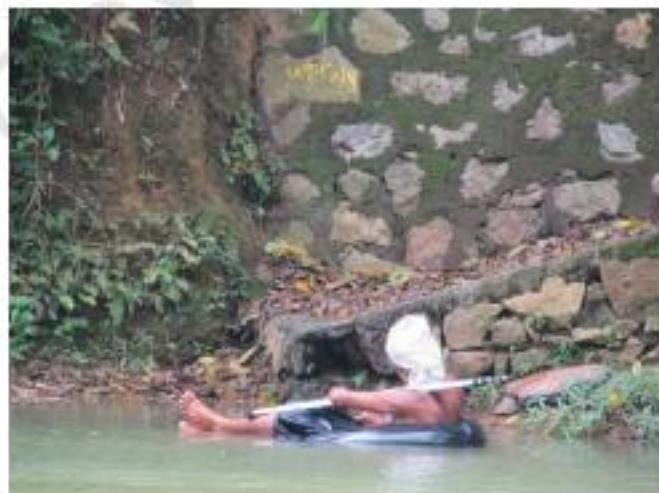
PROFILE - 19
OTTASEKHARAMANGALAM GRAMA PANCHAYAT
TBM: Side wall constructed on the left bank at Nilamannikadavu

The current river cross-section falls at the Nilamannadikadavu of Ottasekharamangalam Grama panchayat. It lies between 08°29'42.6" N latitude to 77°07'15.1"E longitude .The side wall of the kadavu on the left bank is taken as Benchmark which is 8423m downstream of Neyyar Reservoir Bridge.

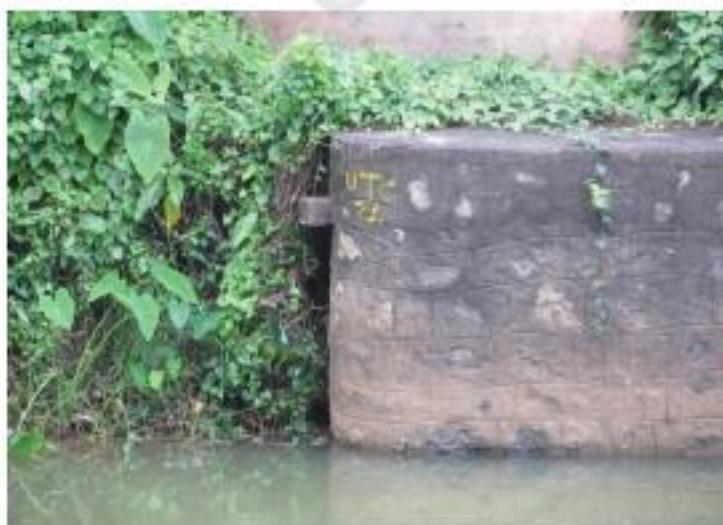
PROFILE - 20
OTTASEKHARAMANGALAM GRAMA PANCHAYAT
TBM: Parapet of Water Tank (KWA) on the Left Bank.

The current river cross-section has taken from 100m north of Mandapathinkadavu Bridge. The bench mark of the present profile is on parapet of water tank of Kerala Water Authority in Ottasekharamangalam Gramapanchayat on the left bank. It lies between 08°29'42.6'' N latitude to 77°07'15.1''E longitude.

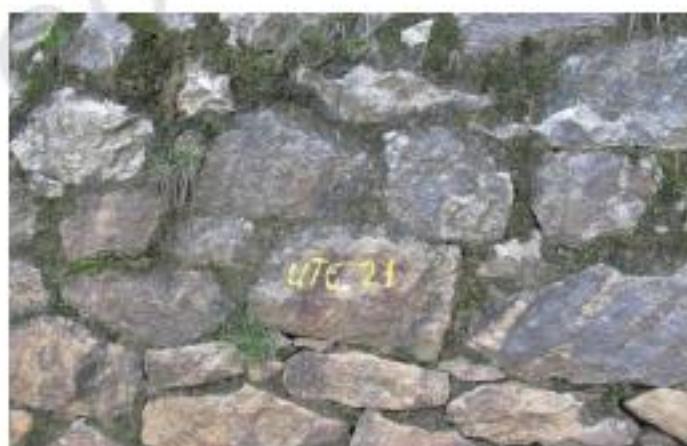
PROFILE - 21
OTTASEKHARAMANGALAM GRAMA PANCHAYAT
TBM: Concrete side wall constructed near kadavu on the left bank

This river cross-section has taken from south of Mandapathinkadavu Bridge. The bench mark of the present profile is on the protection wall which falls in the Kuravara ward of Ottasekhaamangalam panchayat. It lies between $08^{\circ} 29' 27.2''$ N latitude and $077^{\circ} 07' 09.28.3$ E longitudes.

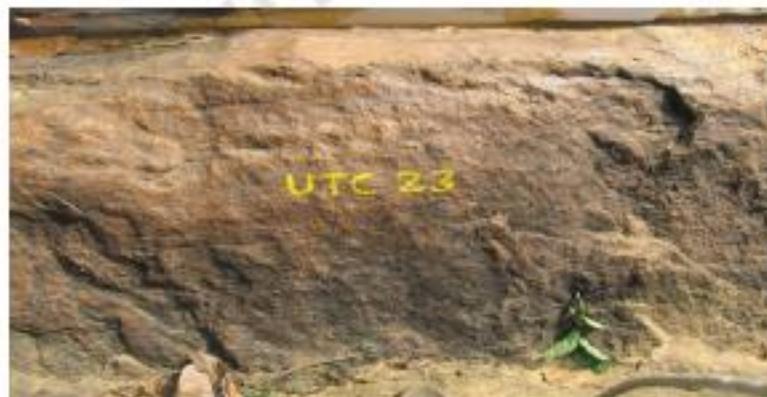
PROFILE - 23
OTTASEKHARAMANGALAM GRAMA PANCHAYAT
TBM: Rock exposure on the left bank

BS	IS	FS	HI	RL	Remarks	Distance
0.460			100.46	100	RBP	0
	2.245			98.215	RBWE	3
	1.15(3.395)			97.065	WD	8
	.80(3.045)			97.415	WD	13
	.80(3.045)			97.415	WD	18
	.40(2.645)			97.815	WD	23
		2.20		98.26	LBWE	28

The current river cross-section falls at 10361 m downstream of Neyyar Reservoir bridge .It lies between 08°29'19.6'' N latitude to 77°07'17.3'' E longitude .The rock exposure on the left bank is taken as Benchmark . The bench mark falls at Kuravara ward of Ottasekharamangalam Gramapanchayat.

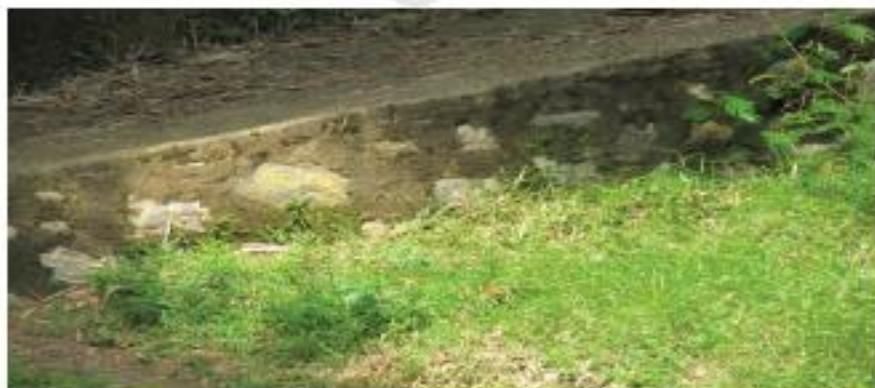
PROFILE - 24
KATTAKADA GRAMA PANCHAYAT
TBM; Side wall constructed on the right bank

BS	IS	FS	HI	RL	Remarks	Distance
1.205			101.205	100	LBP	0
0.645		4.60	97.25	96.605	LBP	10
1.12		3.94	94.43	93.31	LBP	15
	2.29			92.14	LBWE	18
	1.25(3.54)			90.89		23
	1.35(3.64)			90.79		28
	1.10(3.39)			91.04		33
	2.29			92.14		38
		1.17		93.26		43

The current river cross-section falls at Venkanni kadavu which is 340 south of the previous profile. It lies between 08°29'07.9'' N latitude to 77°07'22.9''E longitude .The protection wall the right bank is taken as Benchmark . The bench mark falls at Kattakkada Gramapanchayat.

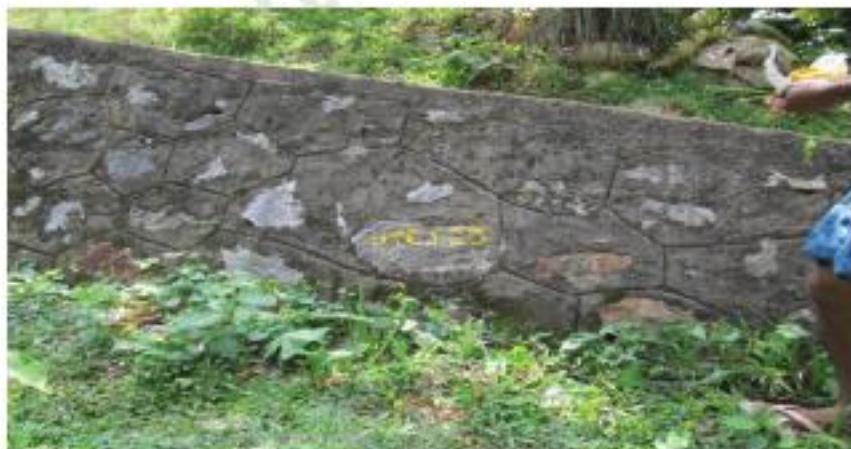
PROFILE - 25
OTTASEKHARAMANGALAM GRAMA PANCHAYAT
TBM: Side wall constructed on the left bank

BS	IS	FS	HI	RL	Remarks	Distance
	35 BM		101.12	100	LBP	0
1.12				97.83	LBWL	10.5
	3.29			97.53		13
	.30(3.59)			97.23		15.5
	.60(3.89)			96.83		18
	1.00(4.29)			96.93		20.5
	.90(4.19)			97.83		23
		3.29

The current river cross-section has taken from Parakkadavu. The Bench mark is marked on the protection wall. It lies between 08°29'072.6'' N latitude to 77°07'26''E longitude. The bench mark falls at Kuravara ward of Ottasekharamangalam Gramapanchayat.

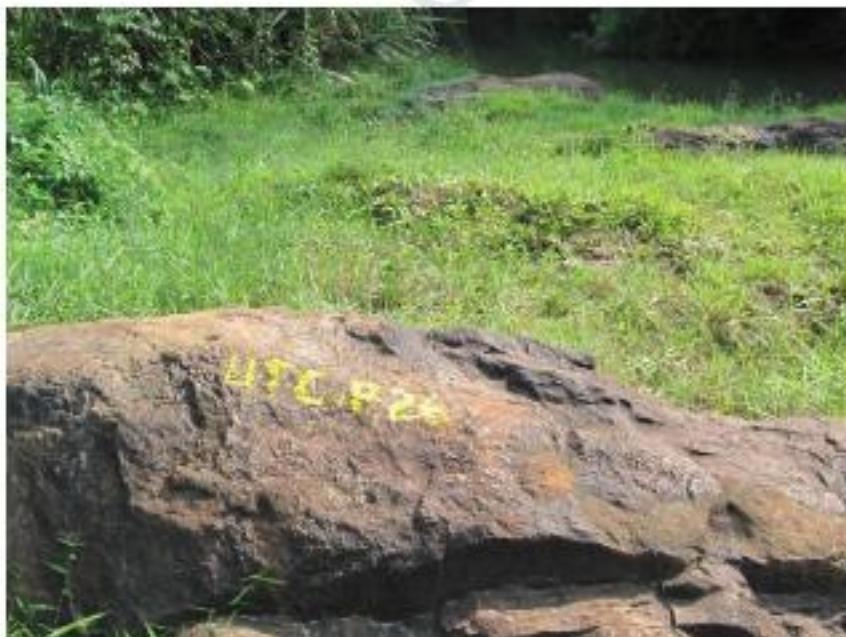
PROFILE-26
OTTASEKHARAMANGALAM GRAMA PANCHAYAT
TBM: Rock exposure on right bank at Parakkadavu

BS	IS	FS	HI	RL	Remarks	Distance
0.575			100.57	100	LB (BM)	0
	0.92			99.65	LBP	5
	2.79			97.78	LBWL	9
	.90(3.69))			96.88	WD	14
	1.3 (4.09)			96.48	WD	19
	1.2(3.99)			96.58	WD	24
	.80(3.59)			96.98	WD	29
		2.79		97.78	RBWL	33

This river cross-section has take from Parakkadavu.. The bench mark of the present profile is on the rock exposure on the left bank which falls in the Kuravara ward of Ottasekhaamangalam panchayat. It lies between $08^{\circ} 28' 43.2''$ N latitude and $077^{\circ} 07' 28.0$ E longitudes.

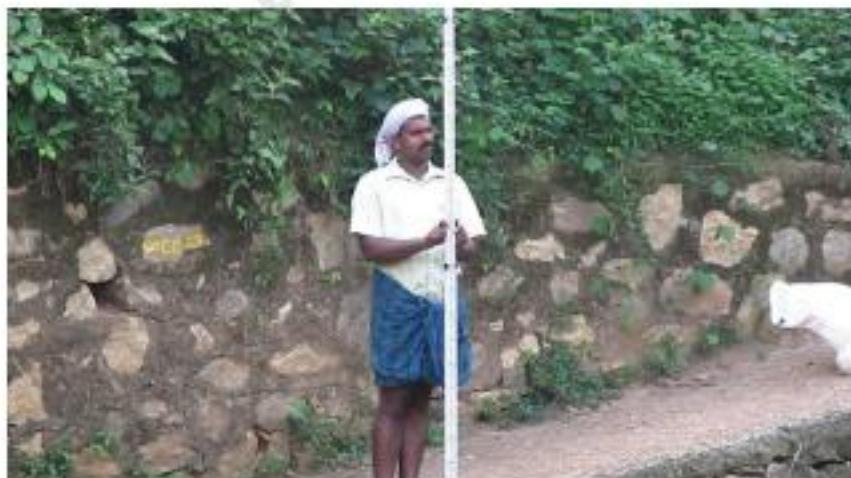
PROFILE - 27
KATTAKKADA GRAMA PANCHAYAT
TBM: Protection wall constructed on the right bank at Munnattumukku

BS	IS	FS	HI	RL	Remarks	Distance
2.595		1.83	102.595	100	LBP	0
	2.03		101.83	98.8	LBWE	8.6
	1.40(3.43)			98.4	WD	13.6
	.90(2.93)			98.9	WD	18.6
	2.00(4.03)			97.8	WD	23.6
	1.14			98.66	WD	28.6
	1.98(4.01)			97.82	RBWE	33.6
	1.60			100	RBP	34.6
		0.625		101.97	RBP	36.6

The current river cross-section falls at the Munattu Mukku of Aryan code Grama panchayat. It lies between 08°28'33.9" N latitude to 77°07'15"E longitude. The benchmark of this river cross section is on the protection wall on the right bank. A water tank of KWA is located on the right bank.

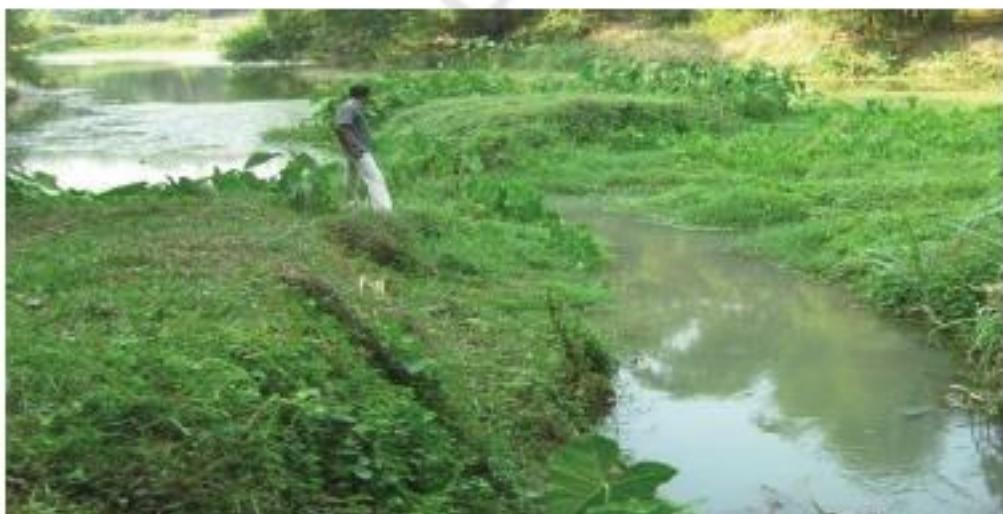
PROFILE - 28
ARYANCODE GRAMA PANCHAYAT
TBM: Kukkidi Ar. joining on the left bank at Kukkidimoola

BS	IS	FS	HI	RL	Remarks	Distance
0.67			100.67	100	LBP(BM)	0
	1.875			98.795	LBP	10
	2.02			98.65	LBWL	21
	.10(2.12)			98.55	WD	26
	.50(2.5)			98.17	WD	31
	1.05(3.07)			97.6	WD	36
	2.02			98.65	RBWL	41
		.99		99.68	RBP	43

The current river cross-section falls at the Kukkidimoola kadavu of Aryancode Grama panchayat. It lies between 08°28'24.4." N latitude to 77°07'28.3"E longitude. The benchmark of this river cross section is the meeting point of Kukkidi Ar on the left bank

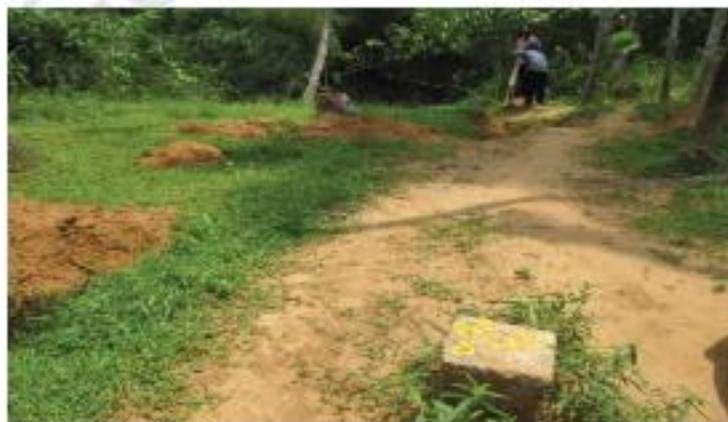
PROFILE - 29
ARYANCODE GRAMA PANCHAYAT
TBM: Survey Stone on the left bank at Mylakkarakadu

BS	IS	FS	HI	RL	Remarks	Distance
0.845			100.845	100	LB	0
	2.26			99.66	LBP	7
	4.895			97.025	LBP	17
3.56				94.39	LBP	20.5
	1.82			94.41	LBWL	21
	.70(2.52)			93.71	WD	26
	1.10(2.92)			93.31	WD	31
	1.00(2.82)			93.41	WD	36
	.7(2.52)			93.71	WD	41
	1.82			94.39	RBWL	46
		.73		95.5	RBP	48.5

The current river cross-section falls at the Mailakkara kadavu of Aryancode Grama panchayat. It lies between 08°28'24.5" N latitude to 77°07'15"E longitude. The benchmark of this river cross section is on a survey stone on the left bank.

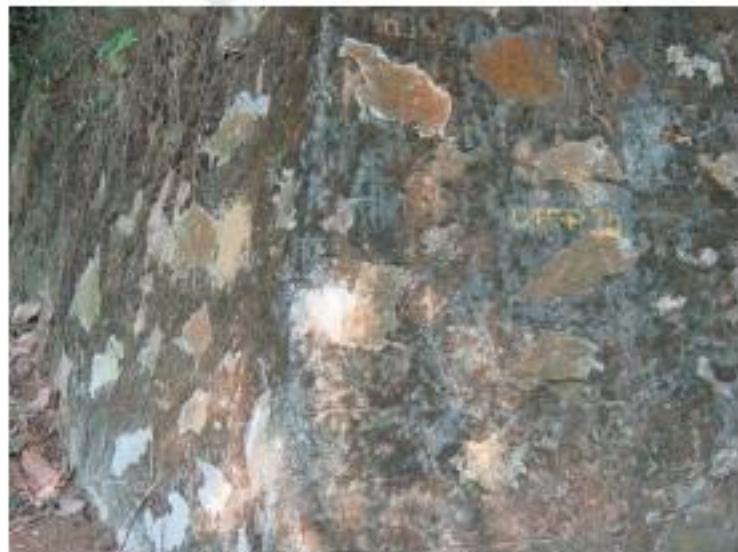
PROFILE - 30
ARYANCODE GRAMA PANCHAYAT
TBM: Protection wall on the left bank at Pozhiyallur Mahavishnu Temple Kadavu

BS	IS	FS	HI	RL	Remarks	Distance
0.80			100.8	100	BS(LBP)	0
	1.59			99.21	LBWL	4
	.50(2.09)			98.71	WD	9
	.20(1.79)			99.01	WD	14
	.90(2.49)			98.31	WD	19
	.80(2.39)			98.41	WD	23
		1.59		99.21	RBWL	28

The current river cross-section falls at Pozhiyalloor Mahavishnu temple Kadavu. It lies between 08°28'28.2" N latitude to 77°06'17.3"E longitude. The protection wall of Kadavu on the left bank is taken as Benchmark and is falls on Aryancode Gramapanchayat.

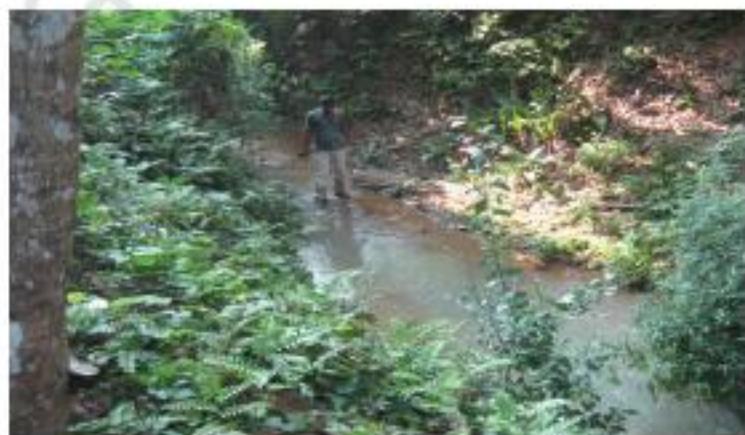
PROFILE - 31
ARYANCODE GRAMA PANCHAYAT
TBM: Machayil Thode joining Neyyar at the left bank

BS	IS	FS	HI	RL	Remarks	Distance
0.81			100.81	100	LBP	0
0.975			97.125	96.15	LBP	15
	1.69			95.455	LBWL	18
	1.60(3.29)			93.925	WD	23
	3.90(5.59)			91.535	WD	28
	4.60(6.29)			90.835	WD	33
	3.90(5.59)			91.535	WD	38
	2.10(3.84)			93.285	WD	43
	1.69			95.435	RBWL	48
		0.36		96.765	RBWL	51

This river cross-section has taken from 642 m south of Pozhiyanalloor Mahavishnu temple kadavu. This cross section is the meeting point of Machayil thodu to the Neyyar. Joining point is taken as the benchmark which falls in Aryancode Gramapanchaayat. It lies between 08°28'15.7.'' N latitude to 77°06'51.9.'' E longitude.

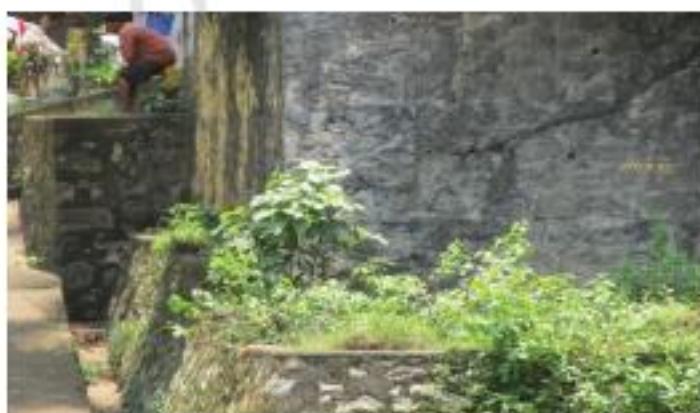
PROFILE - 32
KATTAKKADA PANCHAYAT
TBM: Protection wall constructed near KWA Pump House at Keezharoor kadavu

BS	IS	FS	HI	RL	Remarks	Distance
1.085			101.085	100	RBP(BM)	
	2.22			98.865	RBWL	3
	2.30(4.52)			96.565	WD	8
	1.85(4.07)			97.015	WD	13
	2.05(4.27)			96.815	WD	18
	2.20(4.42)			96.665	WD	23
	2.71(4.93)			96.155	WD	28
	2.22			98.865	LBWL	33
		1.06		100.025	LBP	36

This river cross section has taken from Keezharoor kadavu. Protection wall of Kadavu on the left bank is taken as benchmark which falls in Aryancode Gramapanchayat. It lies between $08^{\circ}28'12.2''$ N latitude to $77^{\circ}06'38.3''$ E longitude.

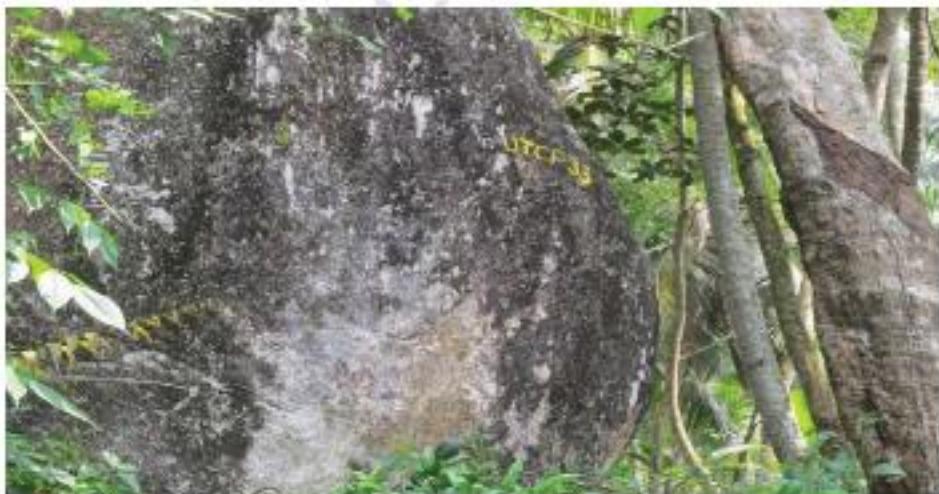
PROFILE - 33
ARYANCODE GRAMA PANCHAYAT
TBM: Rock exposure on the left bank at Madathurai Kadavu

BS	IS	FS	HI	RL	Remarks	Distance
0.10			100.1	100	RMLB	
	0.60			99.5	LB	5
	2.19			97.91	LBWL	10
	2.0(4.19)			95.91	WD	15
	2.65(4.84)			95.26	WD	20
	1.06(3.79)			96.31	WD	25
		2.19		97.91	RBWL	30

The present river cross-section has taken from Madathurai kadvu. The bench mark is marked on the rock exposure close to the kadavu which is in the Keezharoor ward of Aryancode Panchayat on the left bank. It lies between 08°29'10.7" N latitude to 77°06'32.4"E longitude.

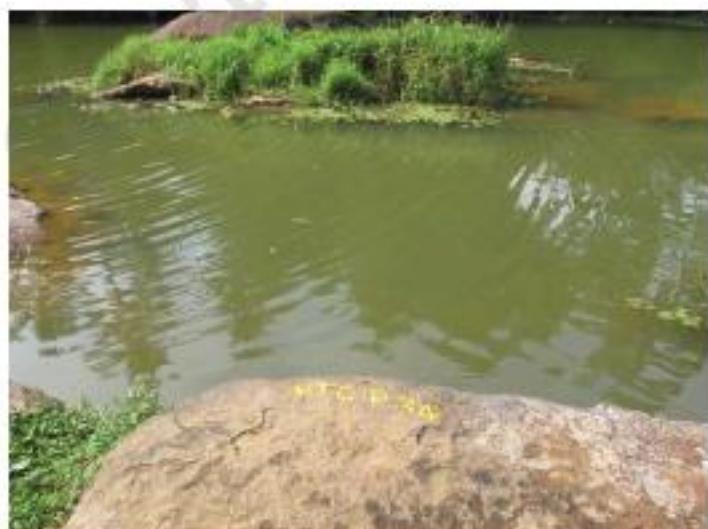
PROFILE - 34
ARYANKODE GRAMA PANCHAYAT
TBM: Rock exposure on the left bank at Kootttilattam kadavu

BS	IS	FS	HI	RL	Remarks	Distance
0.625			100.625	100	BMLBP	0
	1.67			98.955	LBWL	3
	.75(2.42)			98.205	WD	8
	.45(2.12)			98.505	WD	13
	.60(2.27)			98.355	WD	18
	2.00(3.67)			96.955	WD	23
	1.67(3.27)			97.355	WD	28
		1.67		98.955	RBWL	33

The present river cross-section has taken from Kuttillattum Kadavu. The bench mark established here is on the rock exposure on left bank which is in Aryancode Gramapanchayat..It lies between 08°28'10.3" N latitude to 77°06'21.2"E longitude.

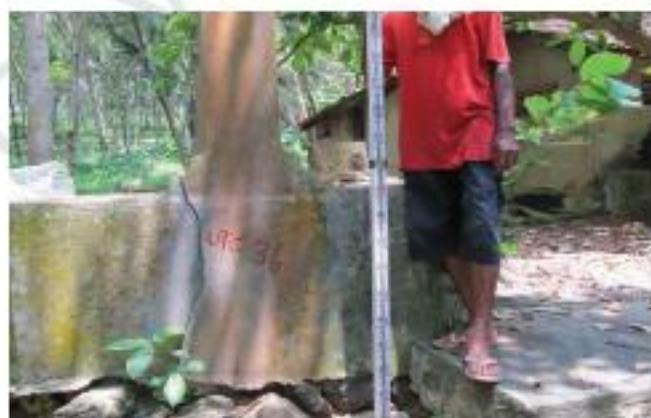
PROFILE - 36
NEYYATTINKARA MUNICIPALITY
TBM: Parapet of a domestic well (House No. 386) on the left bank

BS	IS	FS	HI	RL	Remarks	Distance
0.890			100.89	100	BML	0
1.425		3.960	98.355	98.355	LBWE	9
		4.535		93.81	WD	14
	0.80 (5.335)			93.02	WD	19
	1.70 (6.235)			92.12	WD	24
	2.10 (6.635)			91.72	WD	29
	1.90 (6.435)			91.92	WD	34
	0.80 (5.335)			93.02	WD	39
	0.60 (5.135)			93.22	WD	44
	4.540			93.81	RWE	49

The current river cross-section falls north of Aruvikkara pumphouse..The bench mark is a well on the left bank of the river and is in Aryancode Grama panchayat.

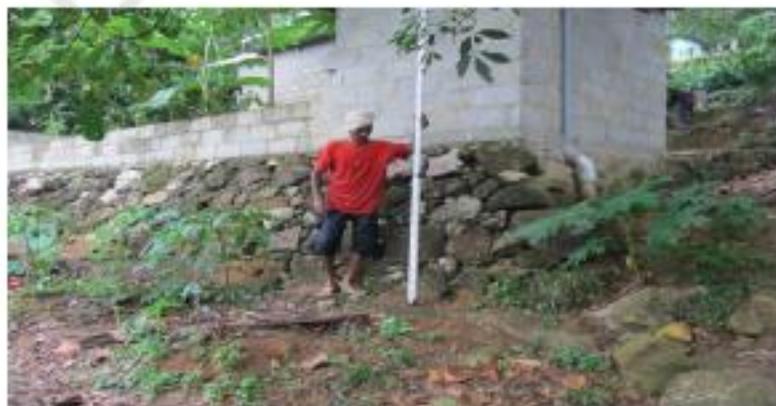
PROFILE - 37
ARYANCODE GRAMA PANCHAYAT
TBM: Basement of protection wall on the left bank

BS	IS	FS	HI	RL	Remarks	Distance
0.040			100.04	100	BM	
	2.90			97.14	LBP	14
	3.745			96.295	LBWE	14.3
	0.70 (4.445)			95.5959	WD	19.3
	1.10 (4.845)			95.195	WD	24.3
	2.10 (5.895)			94.145		29.3
	3.90 (7.645)			92.395		34.3
	2.40 (6.145)			93.895		39.3
	1.50 (5.245)			94.795		44.3
	3.745			96.295	RBWE	49.3
	2.73			97.31	RBP	54.3

The current river cross-section falls in Aruvikkara. The bench mark is the corner of a house on the left bank of the river and is in Aryancode Grama panchayat.

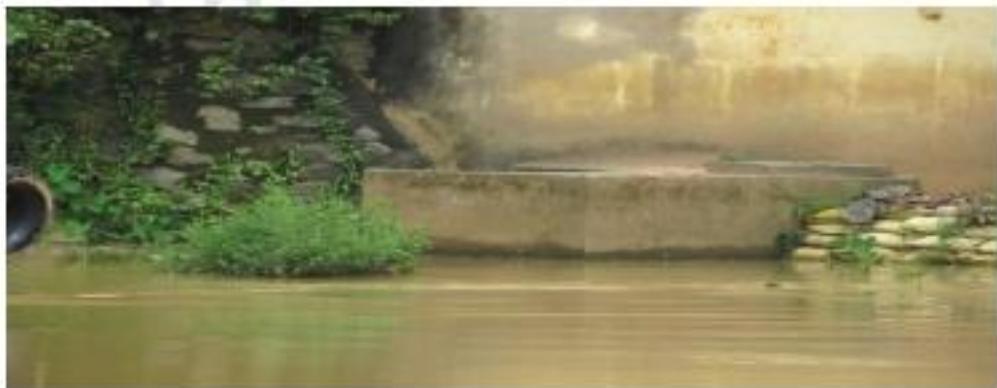
PROFILE - 38
MARANALLOOR GRAMA PANCHAYAT
TBM: Base wall of Pump House on the right bank

BS	IS	FS	HI	RL	Remarks	Distance
1.35			101.35	100	LBP	0
	2.44			98.91	LBWL	4
	.50(2.94)			98.41	WD	9
	1.30(3.74)			97.61	WD	14
	2.50(4.94)			96.41	WD	19
	2.70(5.14)			96.21	WD	24
	1.00(3.44)			97.91	WD	29
	2.80(5.24)			96.11	WD	34
	2.44			98.91	RBWL	39
		1.685		99.45		39.5

The present river cross-section has taken 100 m north of Arivikkara Bridge. The bench mark is established on base wall of Pumphouse on right bank. The bench mark is in the Maranalloor Panchayat. It lies between 08°28'03.6" N latitude to 77°05'22.9"E longitude.

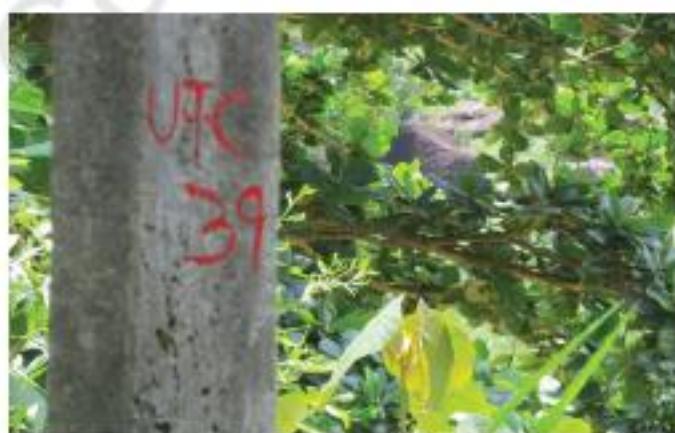
PROFILE - 39
NEYVATTINKARA MUNICIPALITY
TBM: An electric post (EPM=PK67) on the right bank

BS	IS	FS	HI	RL	Remarks	Distance
2.36			102.36	100	RBP	0
0.815		4.99	98.185	97.37	RBW+	5
	1.10(3.66)			94.525	WD	10
	3.10(5.66)			92.525	WD	15
	4.70(7.26)			90.925	WD	20
	5.00(7.56)			90.625	WD	25
	3.60(6.16)			90.025	WD	30
	4.70(7.26)			90.925	WD	35
	3.00(5.56)			92.625	WD	40
				97.37	LBWL	45

The present river cross-section has taken from Kidakuzhi of Aruvikkara ward in Maranalloor Panchayat. An electric post (EPM=PK67) on the right bank has taken as benchmark. River depth is high in this area. It lies between 08°27'49.9" N latitude to 77°05'22.9"E longitude.

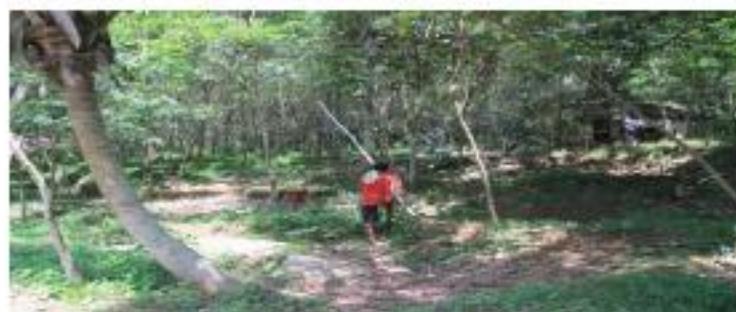
PROFILE - 40
NEYYATTINKARA MUNICIPALITY
TBM: Private Water Tank on the right bank

BS	IS	FS	HI	RL	Remarks	Distance
1.47	(BM)		101.47	100	RB	
	1.5			99.97	RBP	10
	3.525			97.945	RBP	20
	4.255			97.215	RB	25
	0.80(5.055)			96.415	WD	27.5
	4.255			97.215	Rock edge	30
	4.31			97.21	Rock edge	32.5
	1.70(5.955)			95.515	WD	37.5
	1.60(5.855)			95.615	WD	42.5
	0.90(5.155)			96.315	WD	47.5
	4.335			97.21	LBWE	52.5
					LBH	8m

The present river cross-section has taken from Kalluvarambu kadavu Veliamcode ward of Maranalloor Panchayat. Benchmark was established on private water tank on the right bank. It lies between 08°27'33.1" N latitude to 77°05'39.4" E longitude.

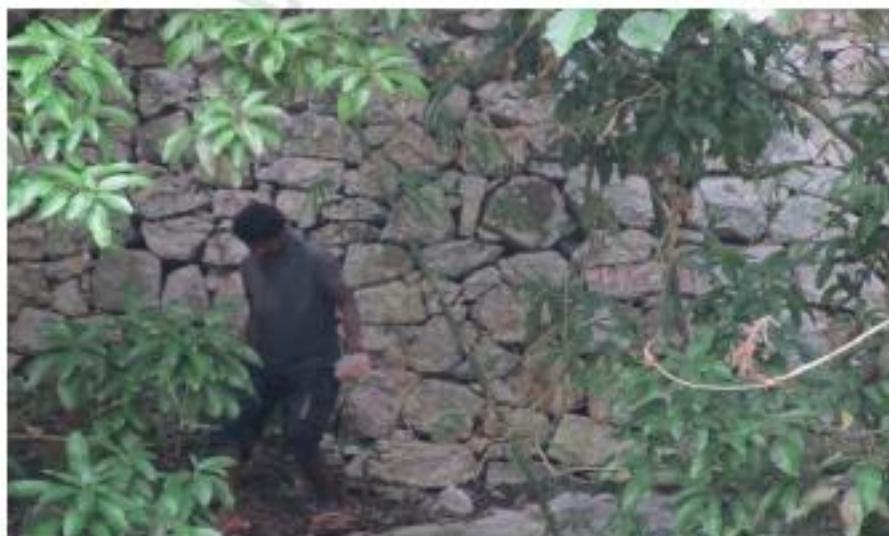
PROFILE- 41
ARYANCODE GRAMA PANCHAYAT
TBM: Back side Compound wall of a house in survey no.220

BS	IS	FS	HI	RL	Remarks	Distance
0.69			100.69	100	RB(LB)	0
	1.94			98.75	LBWL	19
	1.5(3.44)		ROCK	97.25	WD	20
	1.94			98.75	WL	21.5
	1.6M(3.54)			97.15 (ROCK)	WD	22.5
	1.94			98.75	WL	27.5
	2(3.94)			96.75	WD	33.5
	1.94			98.75	RBWL	36
		1.935		98.755	RBP	38.5

The present river cross-section has taken from Erattinpuram in Pasuvannara ward of Aryancode Grama panchayat. Benchmark was marked on backside of compound wall of a house in survey no.220. It lies between 08°27'27.1" N latitude to 77°05'27.3"E longitude.

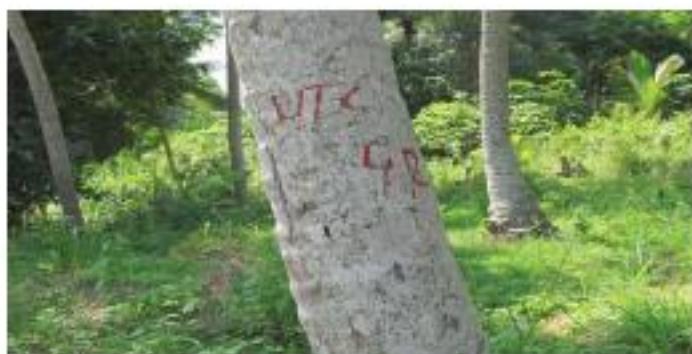
PROFILE - 42
NEYYATTINKARA MUNICIPALITY
TBM: Coconut tree on the right bank near a river island at Erattinpuram south

BS	IS	FS	HI	RL	Remarks	Distance
1.00					BM(RB)	0
0.94		3.24	100.94	100	CPI(RB)	0
	3.665		97.275	97.275	RBWL	2m
	84(4.515)			96.425	WD	45m
	.95(4.615)			96.325	WD	9.5
	1.30(4.965)			95.975	WD	14.5
	1.35(5.015)			95.925	WD	19.5
	1.60(5.265)			95.675	WD	24.5
	.65(4.31)			96.63	WD	29.5
	.90(4.565)			96.375	WD	34.5
	3.74			97.2	LBWL	39.5
		1.56		99.38		44.5

The present river cross-section has taken from Elavanikkara ward of Neyyattinkara Municipality. The benchmark here is on a tree on the right bank .An island which splits the river is visible .It lies between 08°27'20.4'' N latitude to 77°05'56.3''E longitude.

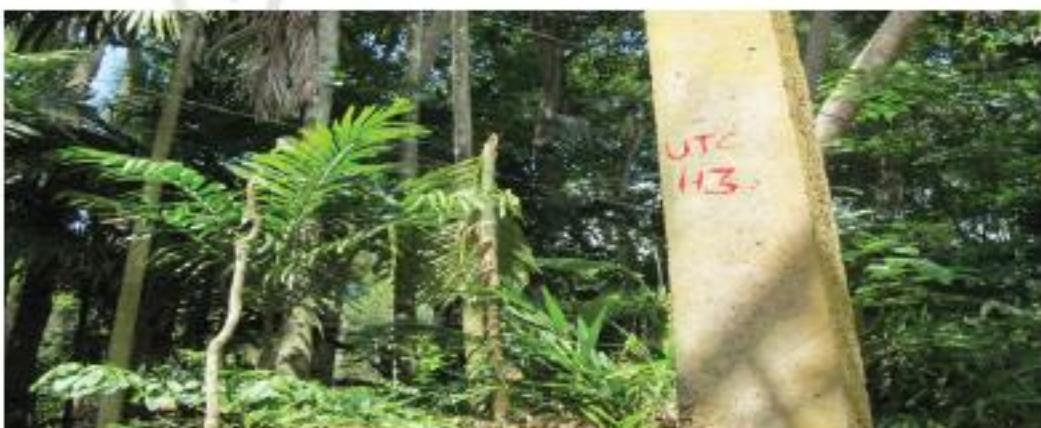
PROFILE 43
NEYYATTINKARA MUNICIPALITY
TBM: Electric post (MV 58/A) on the right bank

BS	IS	FS	HI	RL	Remarks	Distance
	1.41	1.41	101.41	100	RBP	0
1.035		3.18	99.215	98.23	RBP	5m
	2.275			96.99	RBWC	10
	.40(2.675)			95.59	WD	15
	.60(2.875)			96.39	WD	20
	.80(3.075)			96.19	WD	25
	1.05(3.325)			95.94	WD	30
	1.00(3.275)			95.99	WD	35
	2.28			96.99	WD	40
	1.25	1.25		98.01	LBP	41

This river cross-section has taken from Vallakadavu . The bench mark is marked in an electric post on right bank which falls in Neyyattinkara Municipality.Benchmark was established on private water tank on the right bank. It lies between 08°27'17.4" N latitude to 77°06'07.0"E longitude.

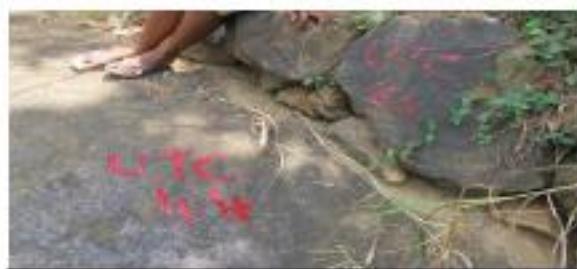
BS	IS	FS	HI	RL	Remarks	Distance
1.195			101.195	100	BM	0
	1.64			99.555	RBP	1m
	1.975			99.22	RBWC	3
	.30(2.275)			98.92	WD	5.5
	.50(2.475)			98.72	WD	10.5
	.40(3.75)			98.82	WD	15.5
	.80(2.775)			98.42	WD	20.5
	1.05(3.205)			97.92	WD	25.5
	1.90(3.875)			97.32	WD	30.5
	.40(2.375)			98.82	WD	35.5
	1.98			99.215	LBWL	40.5
	0.49			100.765	LBP	45.5
		1.195			LBP	49.5

The present river cross-section has taken from Aruvipana .The bench mark is on rock exposure on the right bank which falls in the Elavanikara ward of Neyyattinkara Municipality. Veliamcode ward of Maranolloor Panchayat . It lies between 08°27'07.5'' N latitude to 77°06'14.5''E longitude

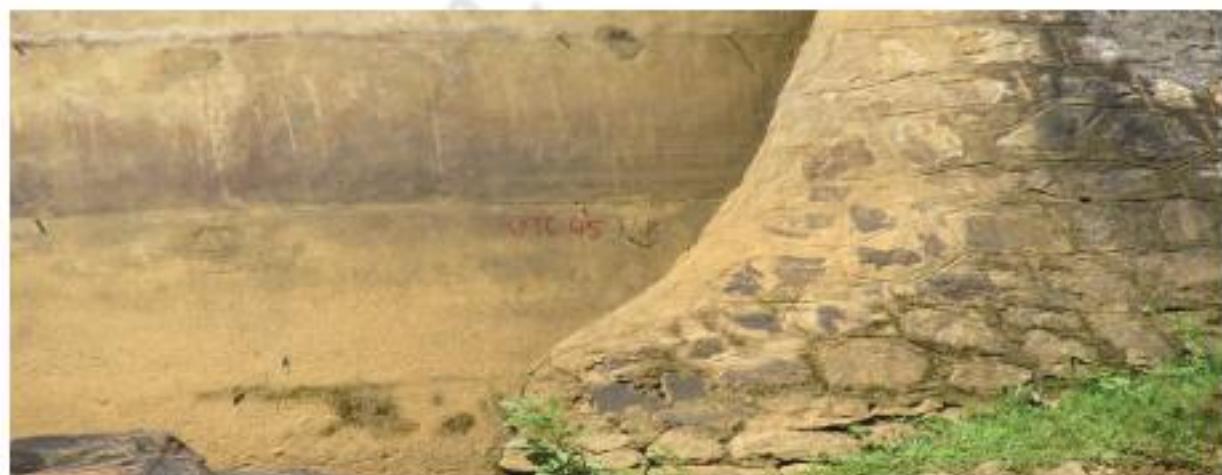
PROFILE-45
NEYYATTINKARA MUNICIPALITY
TBM:Pump House (KWA) on the left bank

BS	IS	FS	HI	RL	Remarks	Distance
132			101.32	100	LBBM	0
	3.32			98	LBWL	4
	.60(3.92)			97.4	WD	5
	.90(4.22)			97.1	WD	10
	1.10(4.42)			96.9	WD	15
	.30(3.62)			97.7	WD	20
	3.52			97.8	RBWL	25
		3.32		98	RBP	30

The present river cross-section has taken from Elavanikkara ward of Neyyattinkara Municipality. Benchmark was established on a pump house on the left bank. It lies between 08°26'56.3" N latitude to 77°06'0.52"E longitude

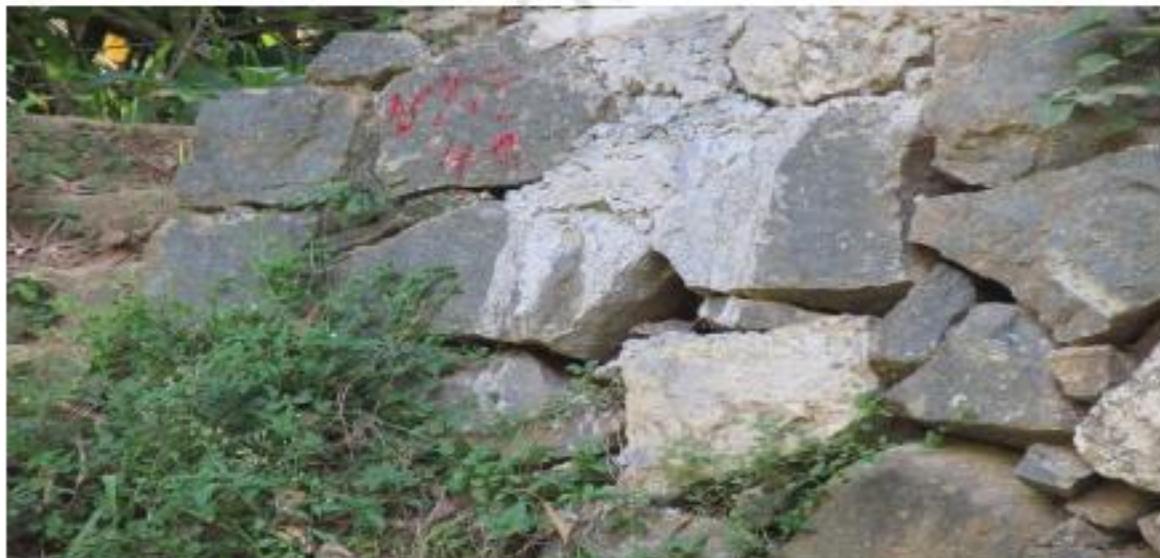
PROFILE - 46
NEYVATTINKARA MUNICIPALITY
TBM: Protection wall on the right bank at Neduvila Kadavu

The present river cross-section has taken from Neduvila kadavu .Protection wall on the right bank is taken as the bench mark which falls in Neyyattinkara Municipality. It lies between $08^{\circ}26'38.4''$ N latitude to $77^{\circ}06'0.41''$ E longitude
