SAND AUDITING IN NEYYAR RIVER

Report

The Neyyar River in southern Kerala has been taken for the river sand auditing programme as per the directions given by State High Level Committee for River Management, Dept. of Revenue, Govt. of Kerala.

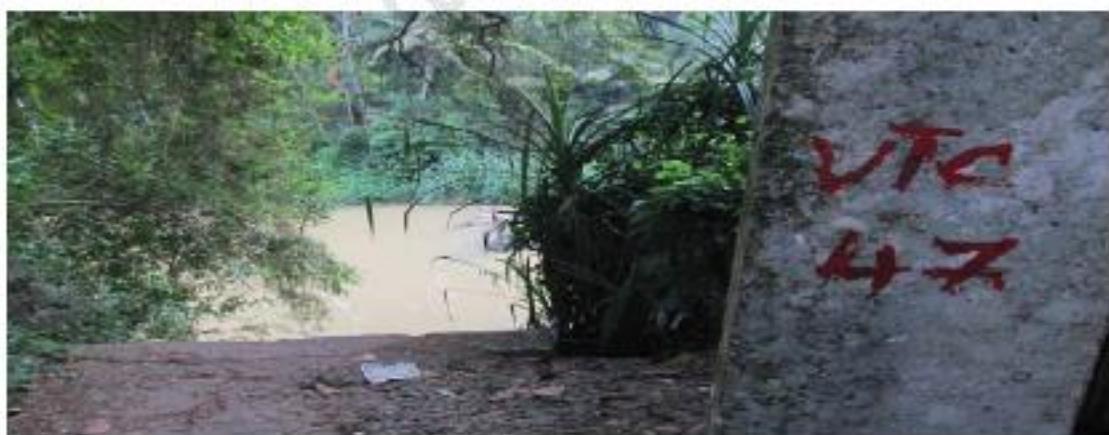
The present river cross-section has taken from Kovil kadavu and is 80 m south of Mampazhakkara bridge. Benchmark was established on an electric post on the right bank. It lies between 08°26'23.3" N latitude to 77°05'54.2"E longitude

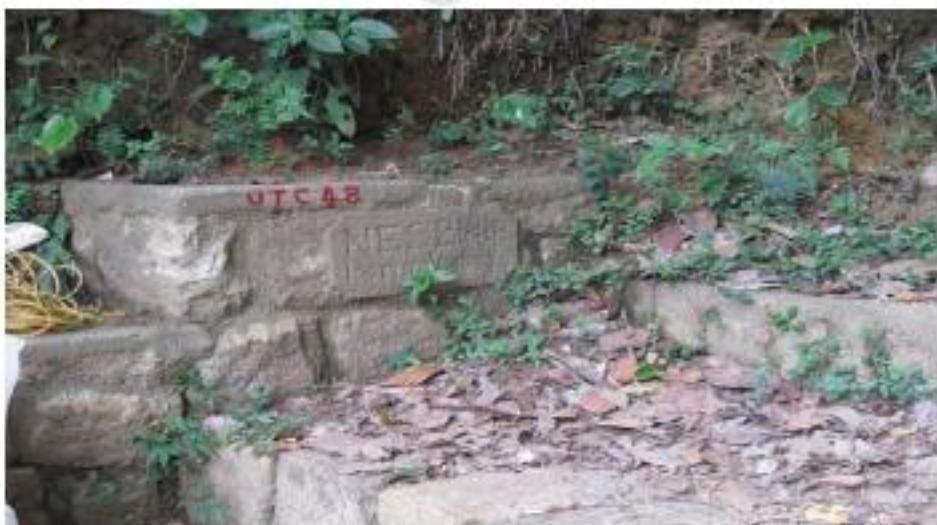
PROFILE- 48

The present river cross-section has taken from Kodithottathu kadavu. The edge of protection wall on the left bank is the bench mark of the present profile which falls in Perumkadavila Panchayat. It lies between $08^{\circ}26'17.4''$ N latitude to $77^{\circ}06'05.4''$ E longitude

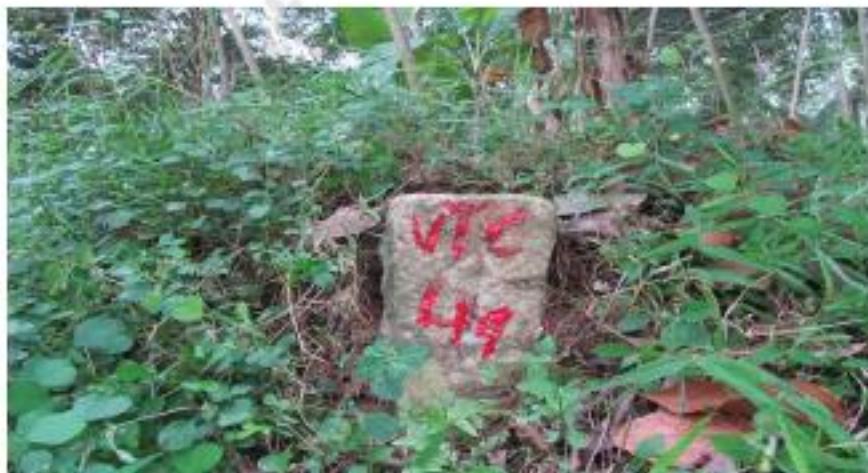
PROFILE 49
PERUMKADAVILA GRAMA PANCHAYAT
TBM: Survey stone on the left bank

The current river cross-section falls at the Thottathu kadavu .The bench mark is on a survey stone the left bank and is in Perumkadavila Grama panchayat. It lies between $08^{\circ}26'13.7''$ N latitude to $77^{\circ}06'02.4''$ E longitude

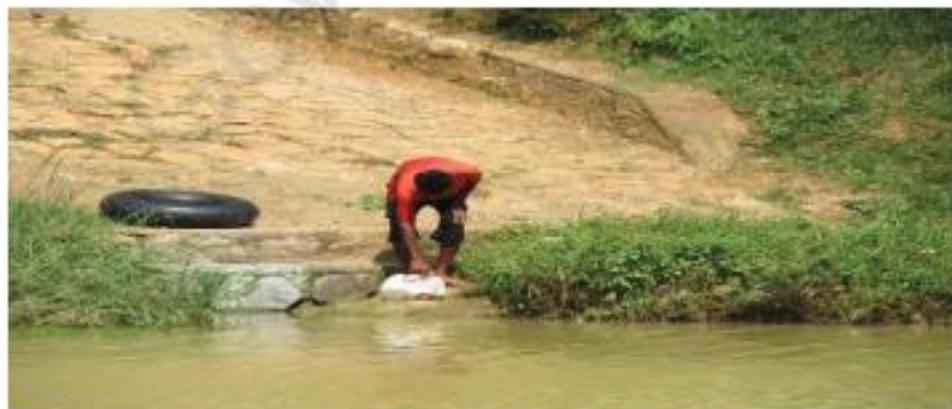
PROFILE 50
PERUMKADAVILA GRAMA PANCHAYAT
TBM: Left side edge of kadavu side wall at Pandarathottam kadavu

The present river cross-section has taken from Pandarathottam kadavu. Benchmark is marked at the edge of kadavu side wall which is in Perumkadavila Panchayat. It lies between 08°26'00.1'' N latitude to 77°05'57.8'' E longitude

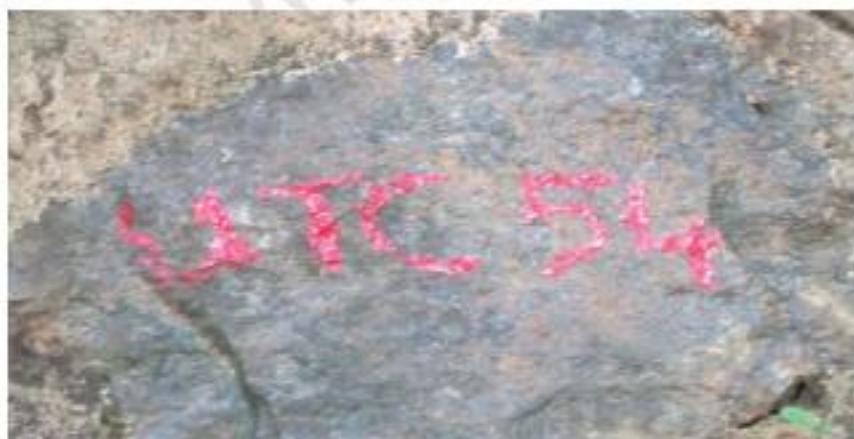
PROFILE -54
NEYYATTINKARA MUNICIPALITY
TBM: Top part of Aruvipuram temple protection wall on the left bank

The present river cross-section has taken from Aruvippuram Temple Kadavu. Benchmark was established at the protection wall on the right bank. It lies between 08°25'25.4'' N latitude to 77°05'35.4'' E longitude

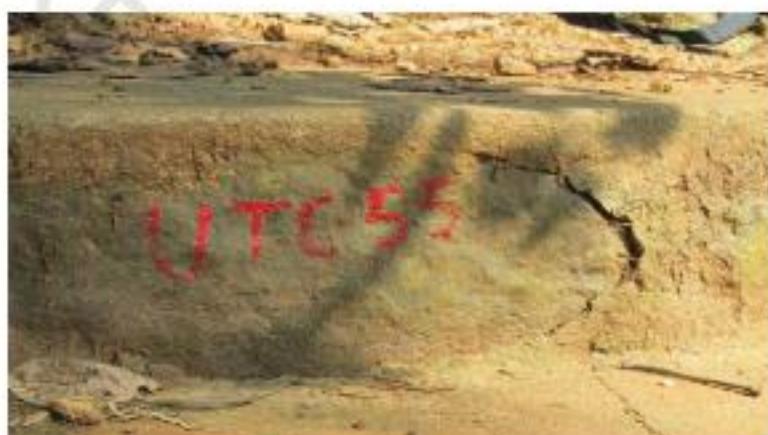
PROFILE-55
NEYYATTINKARA MUNICIPALITY
TBM: First step to the river on the right bank

The present river cross-section has taken from Kunnumanal kadavu in Plavila ward of Neyyattinkara Municipality. Benchmark was established on the step to the Kadavu. It lies between $08^{\circ}25'19.8.''$ N latitude to $77^{\circ}05'33.4.''$ E longitude

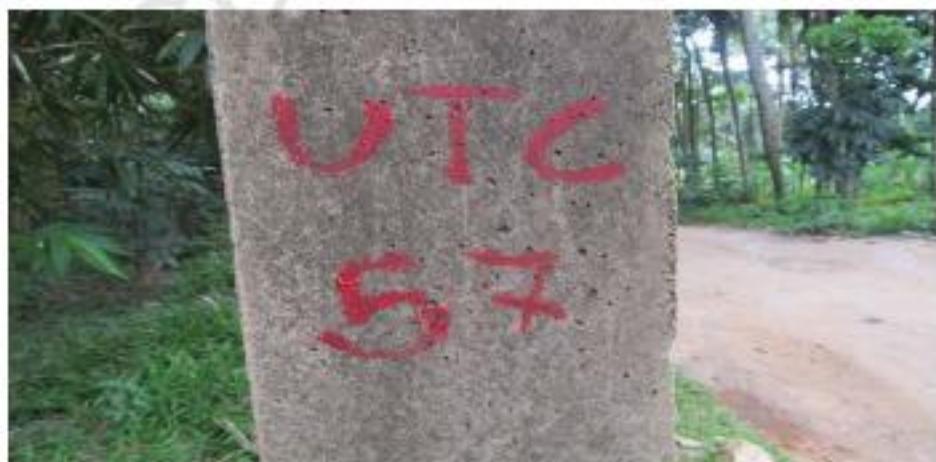
PROFILE - 57
NEYYATTINKARA MUNICIPALITY
TBM: Top part of side wall constructed near Anuvippuram temple.

This river cross-section has taken from Vazhthoor Kadavu of Neyyattinkara Municipality . The bench mark here is in an electric post on the right bank.

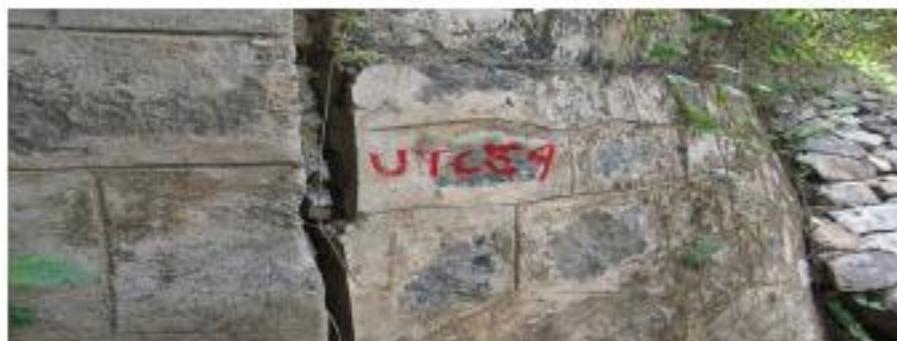
PROFILE - 59
NEYYATTINKARA MUNICIPALITY
TBM: Protection wall south of Arakkunnu bridge

This river cross-section has taken from Arakkunnu kadavu of Neyyattinkara Municipality. The bench mark here is on the protectionwall on the right bank.

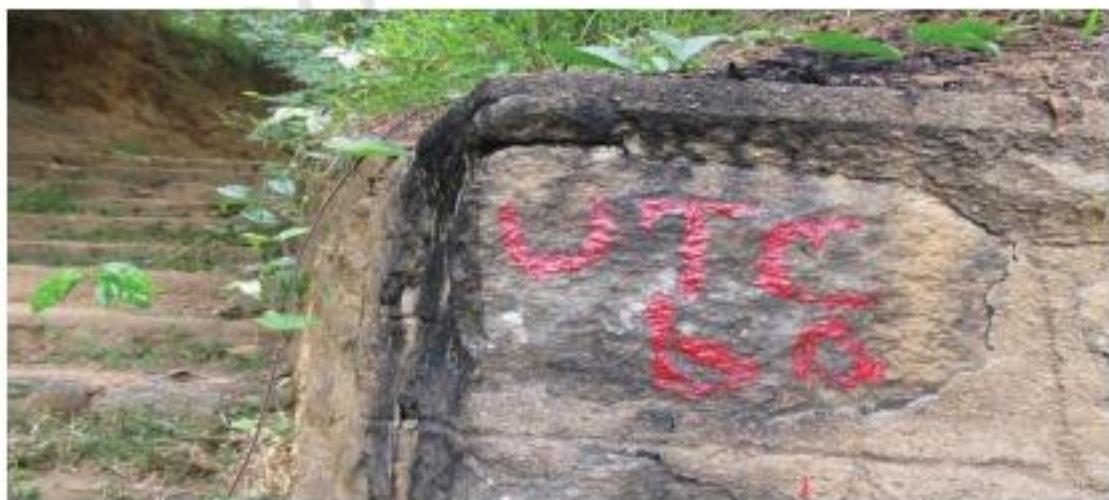
PROFILE - 60
NEYYATTINKARA MUNICIPALITY
TBM: Protection wall on the left bank at Mudippura Kadavu

This profile falls at the Mudippura kadavu of Vazhthoor war of Neyyattin kara Municipality. Edge of protection wall on the left bank is taken as benchmark. It lies between $08^{\circ}24'16.1''$ N latitude and $077^{\circ}05'25.5''$ E longitude

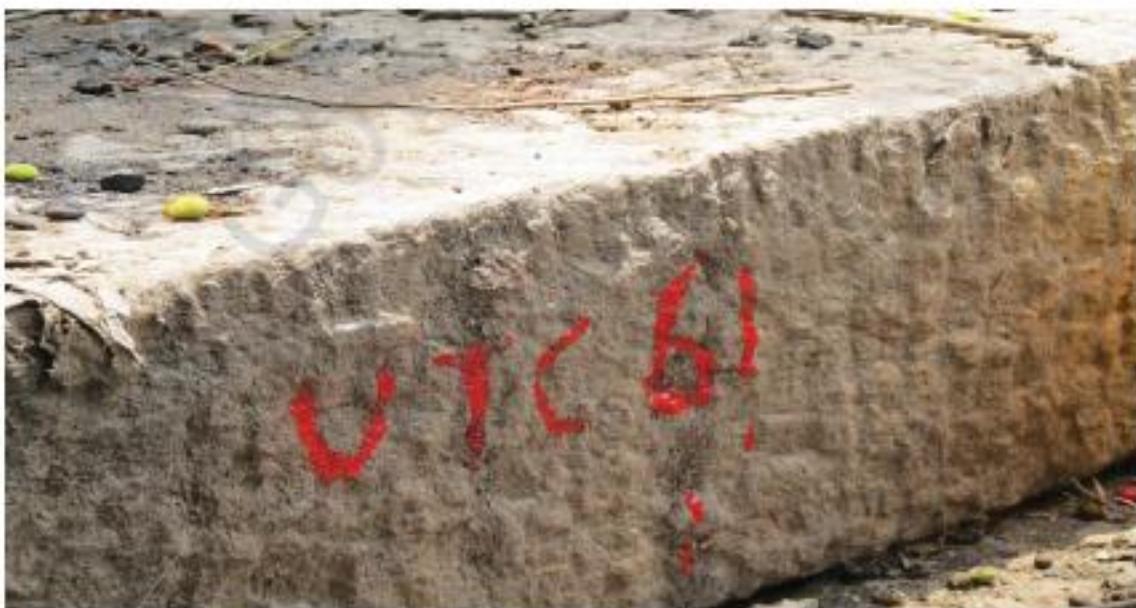
PROFILE - 61
NEYYATTINKARA MUNICIPALITY
TBM: Step (Middle) of Sreekrishna Swami Temple Kadavu

This profile has taken from Neyyattinkara Sreekrishnaswamy Temple kadavu. The benchmark is the step of the Kadavu. It lies between $08^{\circ}24'07.0''$ N latitude and $077^{\circ}05'21.3''$ E longitude

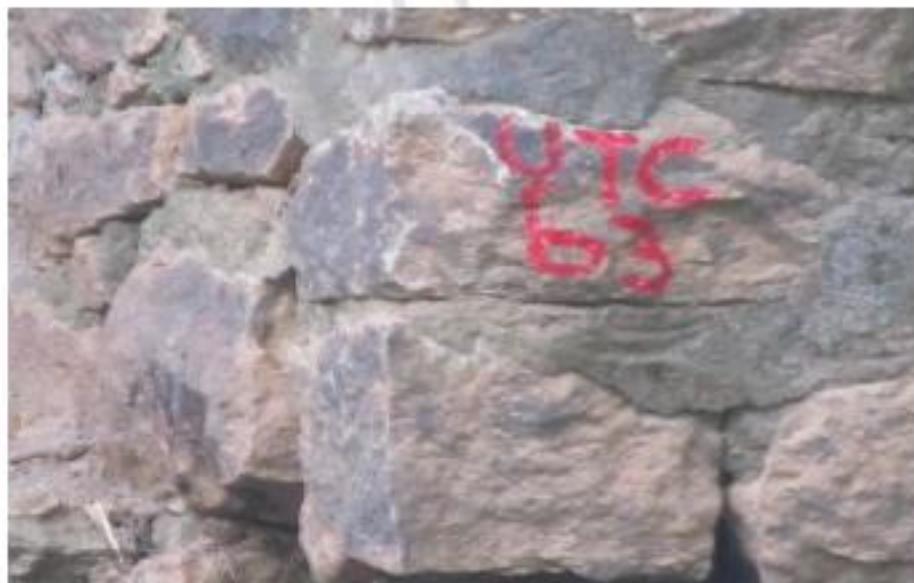
PROFILE - 63
NEYATTINKARA MUNICIPALITY
TBM: Protection wall at Krishnapuram

This profile falls at 200m south of Palakkadavu Bridge. Protection wall on the left bank is taken as benchmark which is in Krishnapuram ward of Neyyattinkara Municipality. It lies between $08^{\circ}23'46.3''$ N latitude and $077^{\circ}05'4.8''$ E longitude

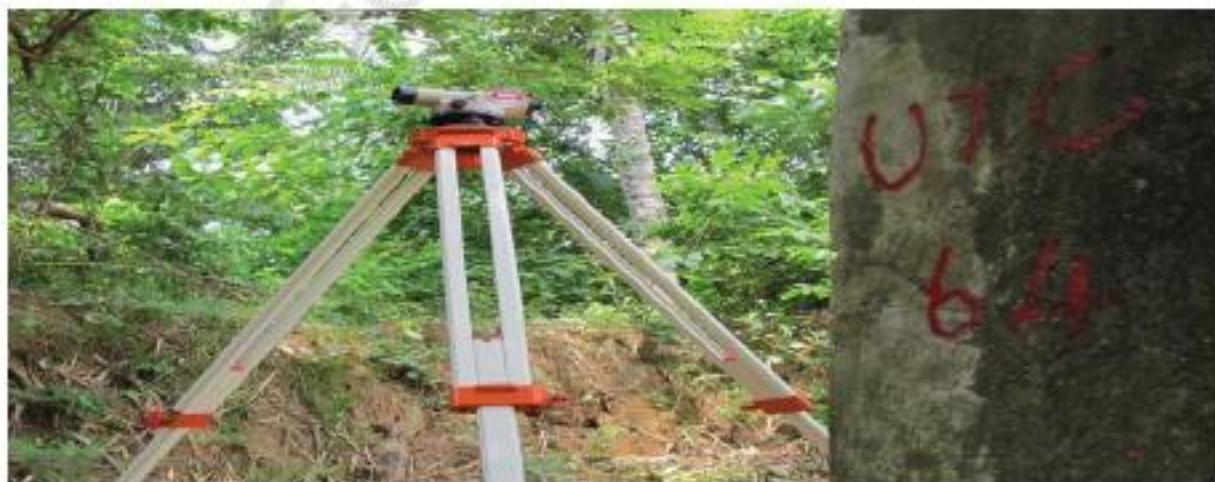
PROFILE - 64
NEYYATTINKARA MUNICIPALITY
TBM: Concrete wall on the right bank at Panavila Kadavu

This profile falls at Panavila ward of Neyyattinkara Municipality. An electric post on the left bank is taken as the benchmark. It lies between $08^{\circ}23'39.5''$ N latitude and $077^{\circ}05'42.5''$ E longitude

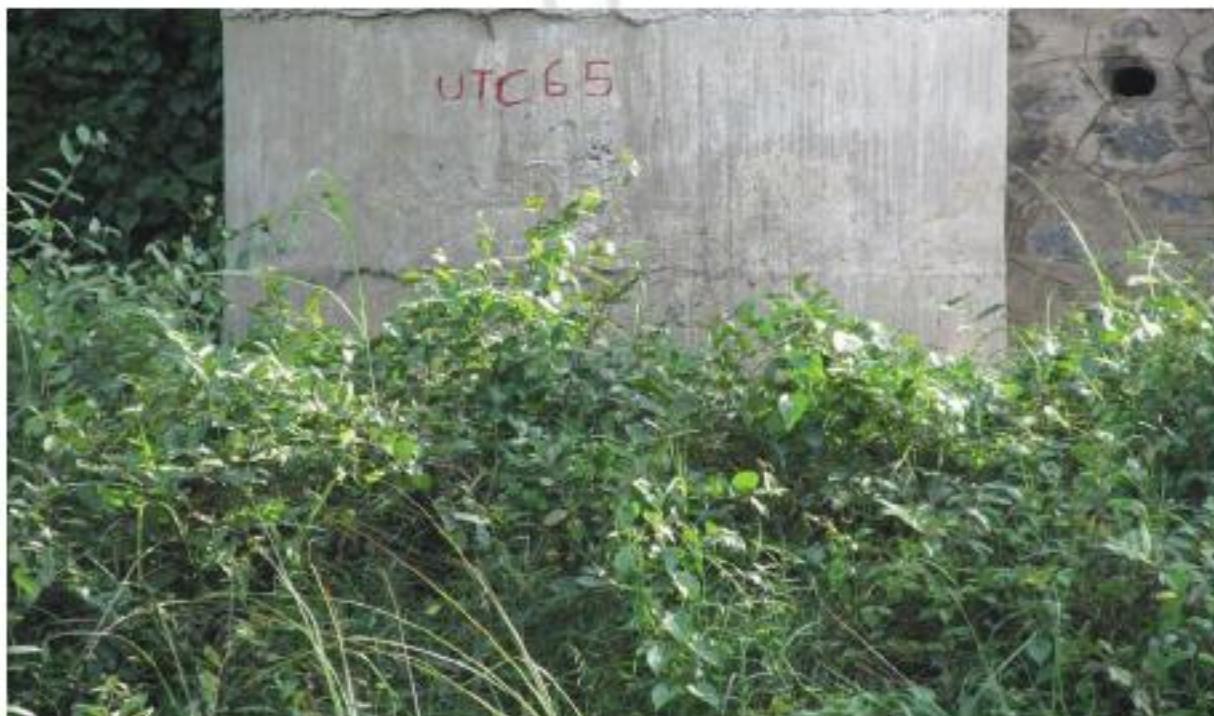
PROFILE - 65
NEYYATTINKARA MUNICIPALITY
TBM: KWA Water tank on the right bank

This profile falls at north of Amaravila bridge where a rain gauging station is located. Lower part of KWA Pumphouse on the right bank is taken as bench mark It lies between $08^{\circ}23'31.3''$ N latitude and $077^{\circ}05'53.2.''$ E longitude

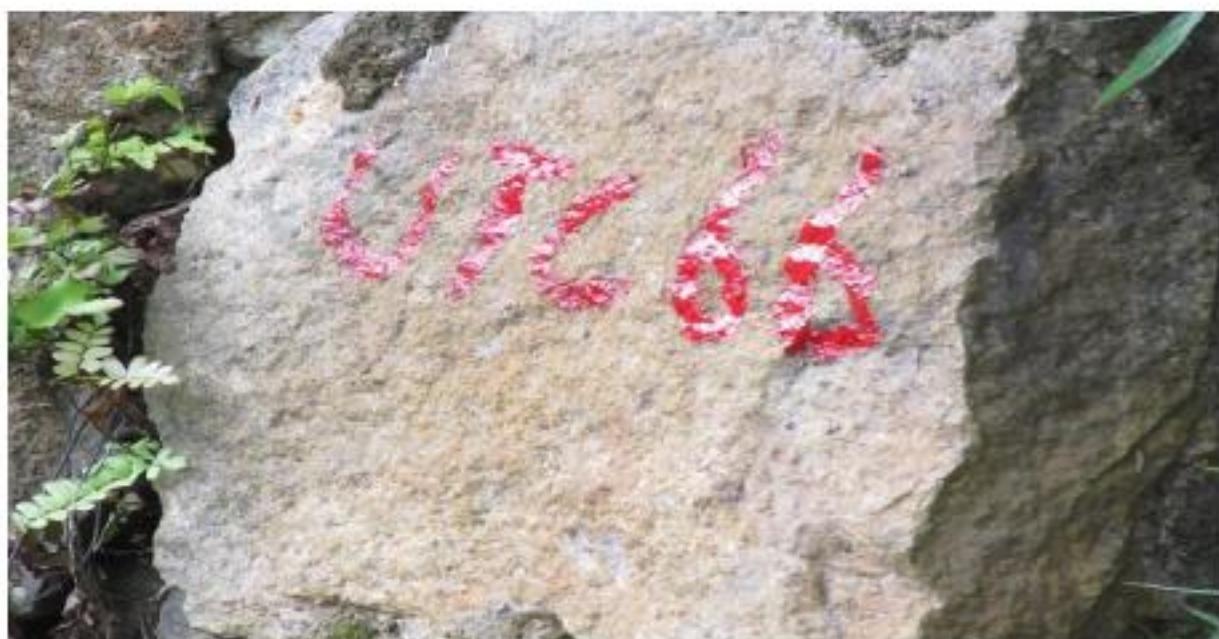
PROFILE - 66
NEYYATTINKARA MUNICIPALITY
TBM: Protection wall on the left bank at Thonikkadavu

This profile has been taken from Thonikkadavu south of Amaravila bridge. The protection wall on the left bank is taken as benchmark. It lies between $08^{\circ}23'20.8''$ N latitude and $077^{\circ}05'46.1''$ E longitude.

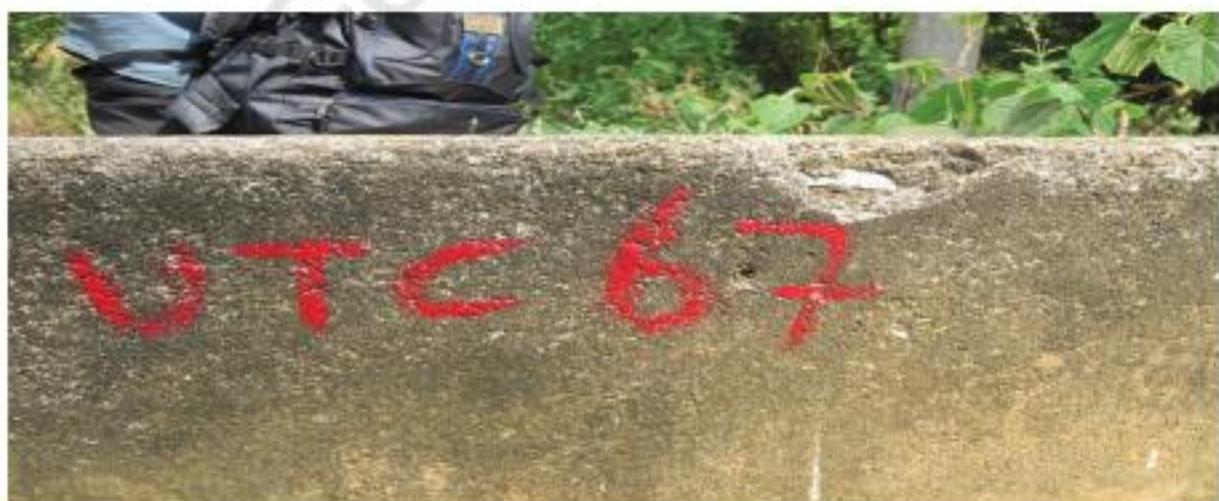
PROFILE- 67
NEYYATTINKARA MUNICIPALITY
TBM: Protection wall on the right bank

This profile falls at the Pullamoola kadavu of Neyyattinkara Municipality. The top part of protection wall on the right bank is taken as benchmark. It lies between $08^{\circ}23'15.5''$ N latitude and $077^{\circ}05'32.7''$ E longitude

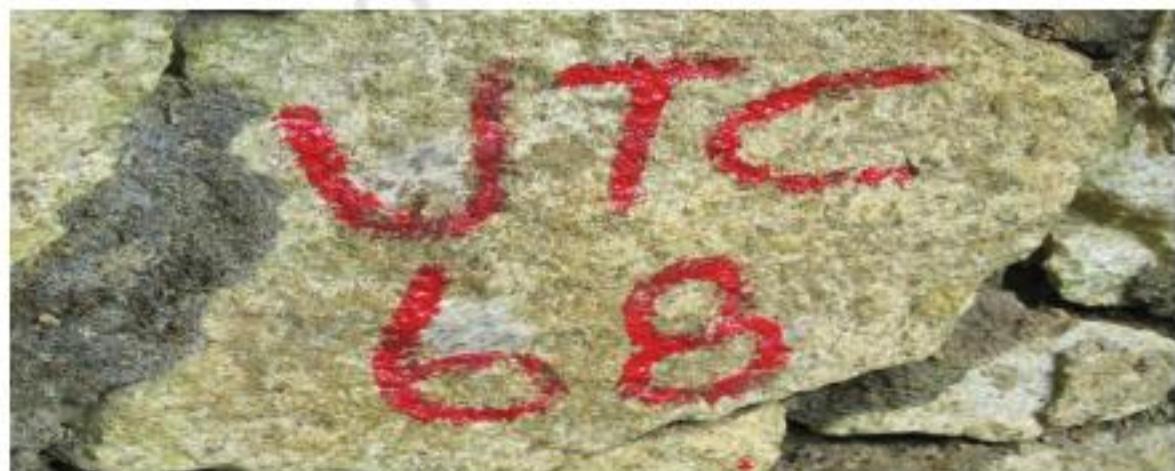
PROFILE - 68
CHENKAL GRAMA PANCHAYAT
TBM: Protection wall on the left bank

This profile falls at Keezhkolla ward of Neyyattinkara Municipality. The protection wall on the left bank is taken as benchmark. It lies between $08^{\circ}23'0.6''$ N latitude and $077^{\circ}05'46.2.6''$ E longitude

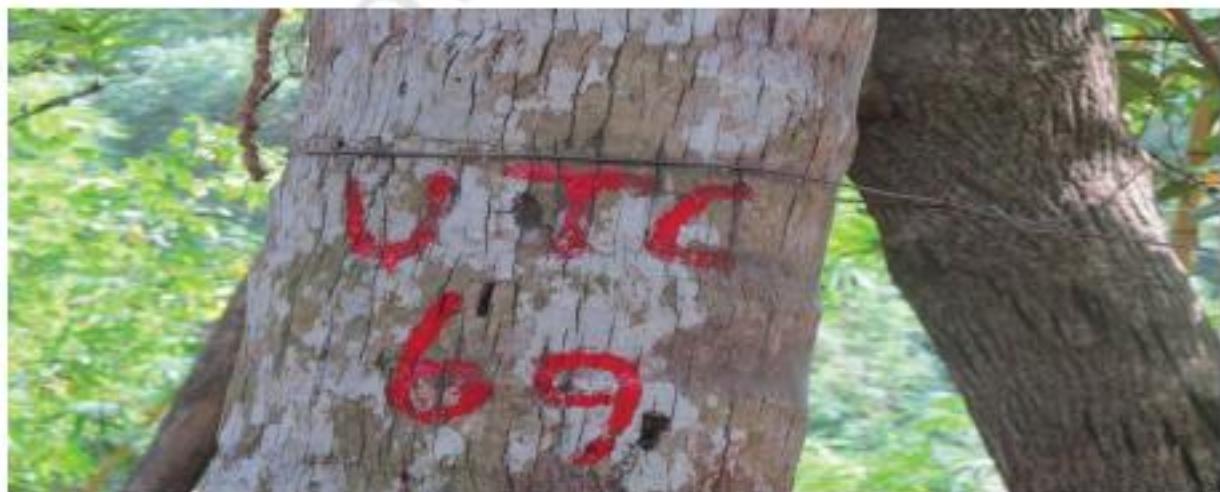
PROFILE - 69
NEYYATTINKARA MUNICIPALITY
TBM: A tree on the left bank at Sabarimuttam kadavu

This profile falls at Sabarimuttam Kadvu of Chenkal Panchayat A tree in the courtyard of house No.72 is taken as benchmark. It lies between $08^{\circ}23'00.9''$ N latitude and $077^{\circ}05'28.6''$ E longitude

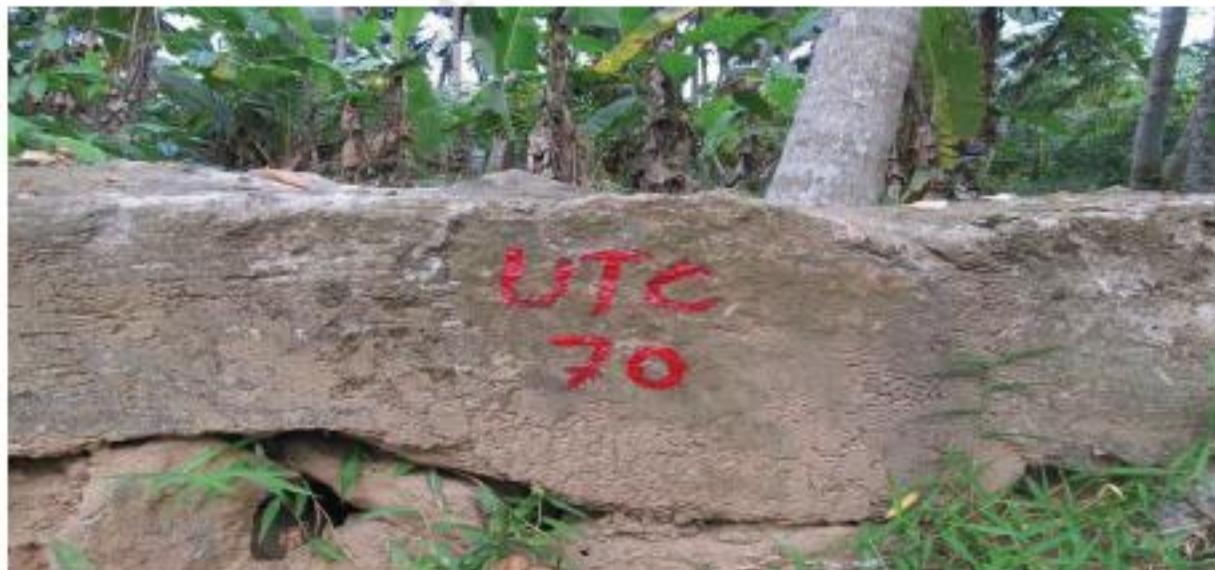
PROFILE - 70
NEYYATTINKARA MUNICIPALITY
TBM: Boundary Protection wall on the left bank

This profile falls at north of Pirayinmoodu bridge. Protection wall of the near plot on the right bank is taken as bench mark. It lies between $08^{\circ}22'50.'' N$ latitude and $077^{\circ}05'16.5.6'' E$ longitude

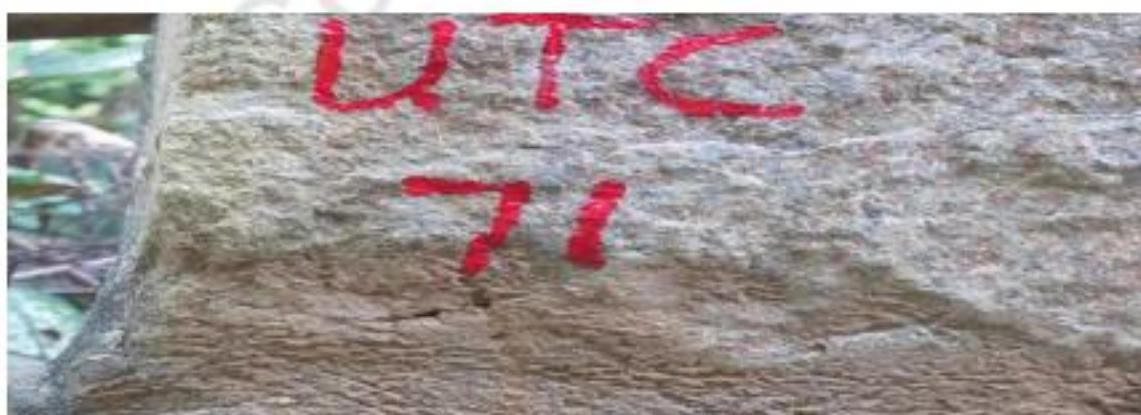
PROFILE - 71
NEYYATTINKARA MUNICIPALITY
TBM: Protection wall on the right bank

This profile falls at Pirayummoodu south of Pirayumode bridge.. Protection wall of the near plot on the right bank is taken as bench mark . It lies between $08^{\circ}22'32.6''$ N latitude and $077^{\circ}05'11.9''$ E longitude

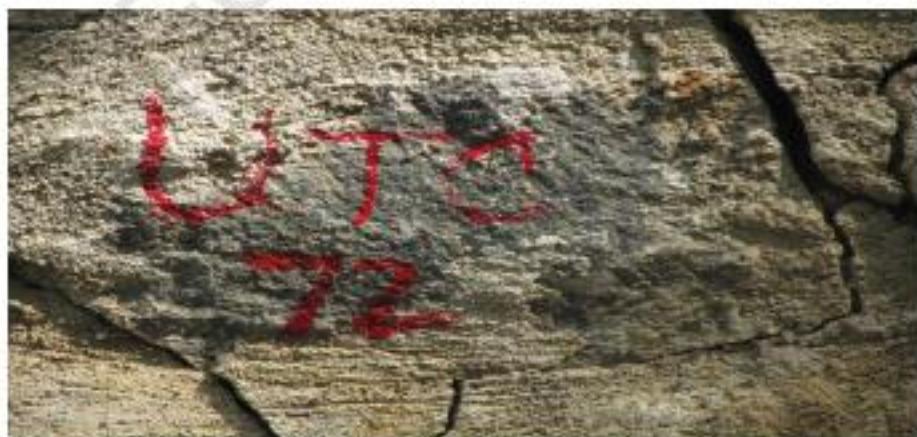
PROFILE-72
Neyyattinkara Municipality
TBM:Protection wall on the right bank at Kodithottathu kadavu

This cross-section falls at the Kodithottathu Kadavu. Benchmark is marked on the protection wall on the right bank and is in Neyyattinkara Municipality. It lies between $08^{\circ}22'30.6''$ N latitude and $077^{\circ}05'0.82''$ E longitude

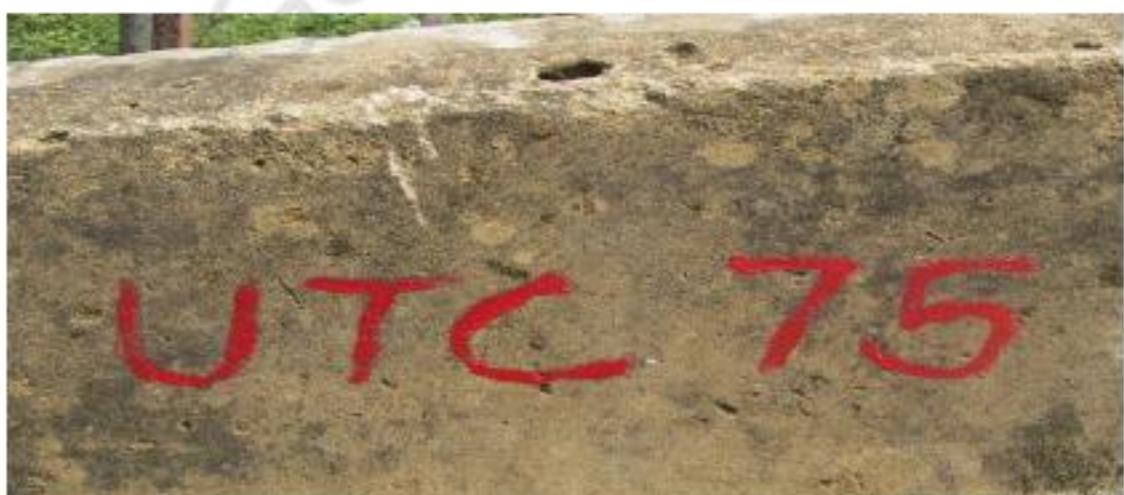
PROFILE - 75
CHENKAL GRAMA PANCHAYAT
TBM: Protection wall on the right bank at Kanjiramkulam Kadavu

This river cross-section has taken from Kanjiramuttu Kadav Neyyattinkara Municipality .
The bench mark here is in the protection wall on right bank.

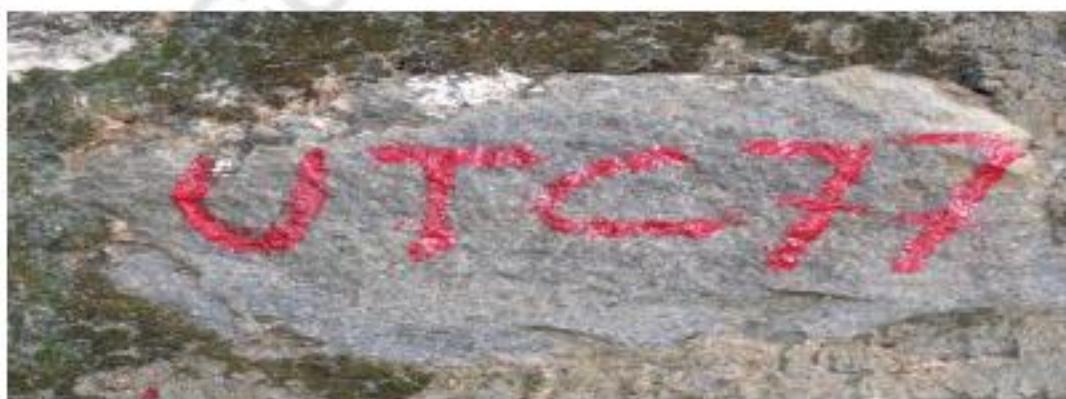
PROFILE - 77
NEYYATTINKARA MUNICIPALITY
TBM: Protection wall on the right bank

The current river cross-section falls at Panchikadukadavu of Mannankallu ward in Thirupuram Pancayat. It lies between $08^{\circ}21'41.8''$ N latitude and $077^{\circ}04'58.4''$ E longitude. The Benchmark is at the protection wall on the right bank

BS	IS	FS	HI	RL	REMARKS	DISTANCE
0.24			100.24	100	BM(RB)	0
	0.725			99.515	RBP	5
	2.415			97.825	RBWL	11
	1.40 (3.815)			96.425	WD	16
	2.30 (4.715)			95.525	WD	21
	4.40 (6.815)			93.425	WD	26
	4.60 (7.015)			93.225	WD	31
	4.40 (6.815)			93.425	WD	36
	4.70 (7.115)			93.125	WD	41
	3.10 (5.515)			94.725	IBW1	46
	2.415			97.825		51

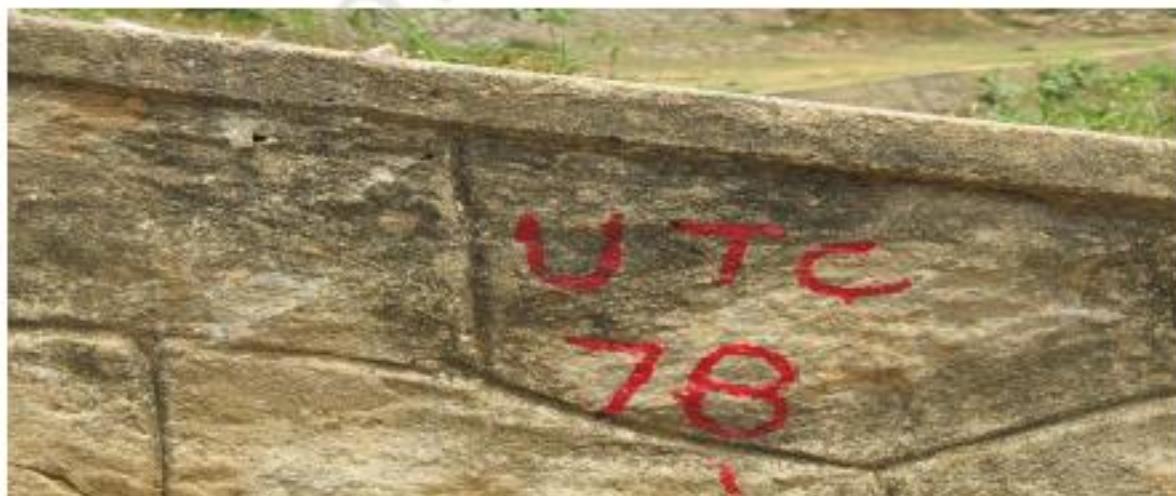
PROFILE - 78
NEYYATTINKARA MUNICIPALITY
TBM: Protection wall on the left bank

The present river cross-section falls at the Pannichanikadavu of Mannankallu ward in Thirupuram Panchayat. It lies between $08^{\circ}21'36.5''$ N latitude and $077^{\circ}05'01.3''$ E longitude. The protection wall on the left bank is taken as benchmark.

BS	IS	FS	HI	RL	REMARKS	DISTANCE
1.335			101.335	100	BM (RB)	0
	2.35			98.985	RBWL	2.5
	1.00 (3.35)			97.985	WD	7.5
	3.60 (5.95)			95.385	WD	12.5
	7.50 (9.85)			91.485	WD	17.5
	7.30 (9.65)			91.685	WD	22.5
	5.90 (8.25)			93.085	WD	27.5
	4.00 (6.35)			95.035	WD	32.5
	2.10 (4.45)			96.885	WD	37.5
		2.35		98.985	WL (LB)	42.5

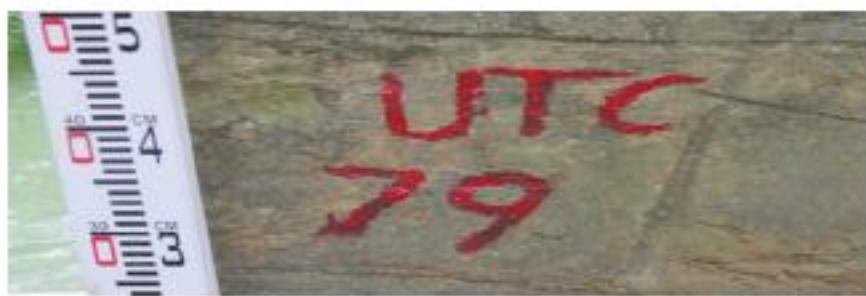
PROFILE - 79
NEYYATTINKARA MUNICIPALITY
TBM: Protection wall on the right bank

The present river cross section falls at the Erayinvilakadavu of Thirupuram Panchayat. The benchmark is at the side of protection wall to kadavu. It lies between $08^{\circ}21'28.7''$ N latitude $077^{\circ}05'08.1''$ E longitude.

BS	IS	FS	HI	RL	REMARKS	DISTANCE
0.09			100.09	100	RBP	0
	1.76	3.985		98.33	RB (BM)	6 m
	3.12			96.97	RBWL	9
	2.00 (5.12)			94.97	WD	14
	2.50 (5.62)			94.47	WD	19
	2.80 (5.92)			94.17	WD	24
	2.70 (5.82)			94.27	WD	29
	2.60 (5.72)			94.37	WD	34
	2.00 (5.12)			94.97	WD	39
	1.80 (4.92)			95.17	WD	44
	2.60 (5.72)			94.37	WD	49
	2.30 (5.42)			94.67	WD	54
	1.90 (5.02)			95.07	WD	59
	3.12			96.97	LBWL	64

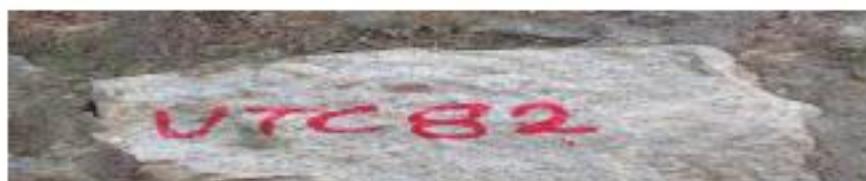
PROFILE-82

This river cross-section taken from ward no. 7 of Thirupuram Panchaya. Bench mark is the sidewall on the right bank of the river. A house (house No. 64) is near to the bench mark and the name of house owner is Ravi. It lies between $08^{\circ}20'50.2''$ N latitude and $077^{\circ}05'15.9''$ E longitude

TBM-Side wall of road on the right bank

BS	IS	FS	HI	RL	REMARKS	DISTANCE
0.94			100.94	100	BM (RB)	0
	2.50			98.44	RBP	5
	3.225			97.715	RBP	10
	3.510			97.43	RBP	15
1.240		3.700	98.48	97.24	RBPC	20
	2.57			95.91	RBWE	24
	1.70 (WD) (4.27)			94.21		29
	4.00 (WD) (6.57)			91.91		34
	4.50 (WD) (7.07)			91.41		39
	5.10 (WD) (7.67)			90.81		44
	4.30 (WD) (6.87)			91.61		49
	3.00 (WD) (5.57)			92.91		54
	2.60 (WD) (5.17)			93.31		51
	060 (WD) (3.17)			95.31		64
	2.57			95.91		65
		2.10		96.27

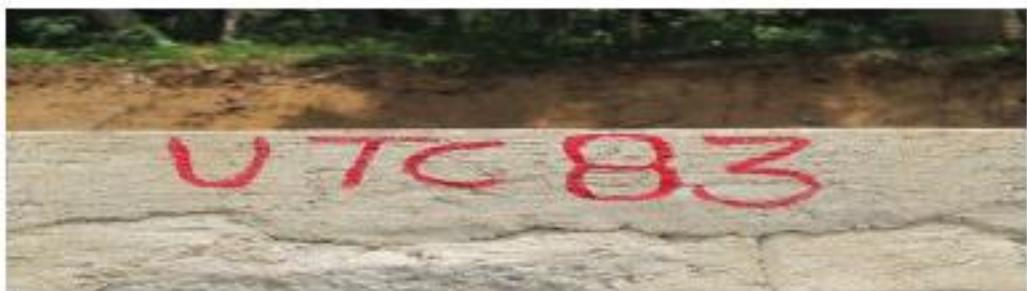
PROFILE-83

This profile of the river falls at the Mavilakkadavu of Thirupuram Panchayat .Right bank side wall of the river is taken as bench mark. It lies between $08^{\circ}20'42.3''$ and $077^{\circ}05'17.2''$ E longitude

TBM Side wall on the right bank

BS	IS	FS	HI	RL	REMARKS	DISTANCE
0.990		1.64	100.99	100	RBP	0
0.5		4.880	96.61	96.11	RBP	40 m
		1.415		95.16	RB	58
		2.390		94.22	RBWE	67.5
		1.00 (3.39)		93.22		70.5
		3.10 (5.49)		91.12		75.5
		3.50 (5.89)		90.72		80.5
		3.80 (6.19)		90.42		85.5
		3.90 (6.29)		89.82		90.5
		3.80 (6.19)		90.42		95.5
	2.90	5.29		91.32		100.5
			2.390	94.22	LBWE	105.5

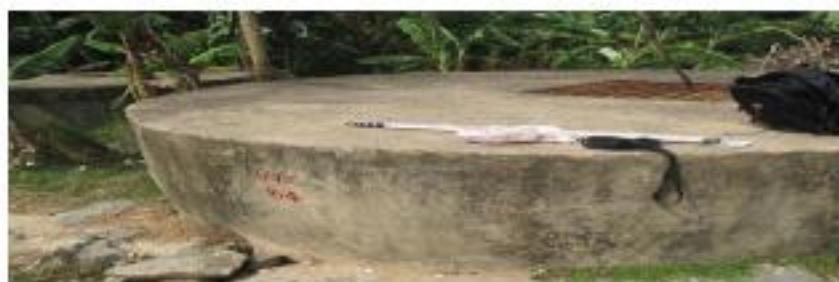
PROFILE-84

The present cross-section falls in the Thirupuram Panchayat. The bench mark is the water tank away from Mavilakkadavu bridge. It lies between $08^{\circ}20'32.1''$ N latitude and $77^{\circ}05'21.8''$ E longitude.

THIRUPURAM GRAMA PANCHAYAT
TBM: Irrigation Water tank on the right bank

BS	IS	FS	HI	RL	REMARKS	DISTANCE
1.55		4.85	101.55	100	RBP (BM)	0
	4.730			96.82	RBWE	4
	0.90 (5.63)			95.92	WD	9
	2.10 (6.8)			94.75	WD	14
	2.70 (7.43)			93.12	WD	19
	2.90 (7.63)			93.92	WD	24
	3.40 (8.13)			93.42	WD	29
	4.10 (9.13)			92.42	WD	34
	3.80 (8.53)			93.02	WD	39
	4.10 (8.83)			92.72	WD	44
	3.40 (8.13)			93.12	WD	49
	0.90 (5.63)			95.92	WD	54
		4.730		96.82	LBWE	59

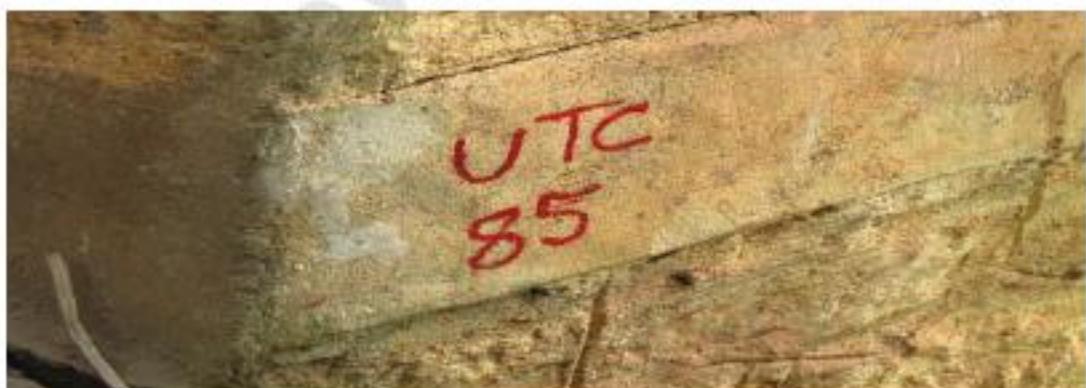
PROFILE-85

This cross-section falls at the ward No. 19 of Kulathoor Panchayat. The bench mark is at the sidewall constructed on the left banks of the river. It lies between $08^{\circ}20'23.9''$ N latitude to $77^{\circ}05'21.8''$ E longitude.

KULATHOOR GRAMA PANCHAYAT
TBM: Edge of protection wall on right bank

BS	IS	FS	HI	RL	REMARKS	DISTANCE
3.52			103.52	100	BM(LB)	0
	4.47			99.65	LBWE	5
	1.00 (5.47)			98.05	WD	10
	3.60 (8.07)			95.45	WD	15
	4.30 (8.77)			94.75	WD	20
	4.40 (8.87)			94.65	WD	25
	3.70 (8.17)			95.35	WD	30
	3.80 (8.27)			95.25	WD	35
	1.80 (6.27)			97.25	WD	40
	4.47			99.05	RBWE	45
		2.715		100.805		47

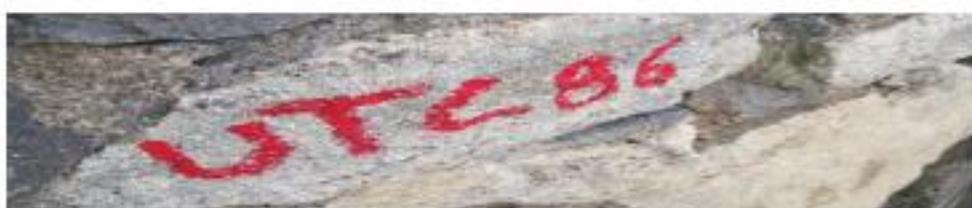
The current cross-section falls at Kottakkakam ward of Kulathoor Panchayat at Korukalkadavu. The bench mark is the side wall constructed on the left bank of the river. It lies between $08^{\circ}20'11.9''$ N latitude and $077^{\circ}05'09.3''$ E longitude

PROFILE-86
KULATHOOR GRAMA PANCHAYAT
TBM, Protection wall at Korukal kadavu on the right bank

BS	IS	FS	HI	RL	REMARKS	DISTANCE
1.09			101.09	100	LB	0
	1.465			99.625	LBP	5
	2.545			98.545	LBWL	10
	1.70 (4.245)			96.845	WD	17
	3.40 (5.945)			95.145	WD	22
	5.50 (8.045)			93.045	WD	27
	6.30 (8.845)			92.245	WD	29
	6.50 (9.045)			92.045	WD	34
	7.00 (9.545)			91.545	WD	39
	5.50 (8.045)			93.045	WD	44
	2.90 (5.445)			95.645	WD	49
	2.545			98.545	RBWL	54
		1.535		99.56	RBP	59
						61

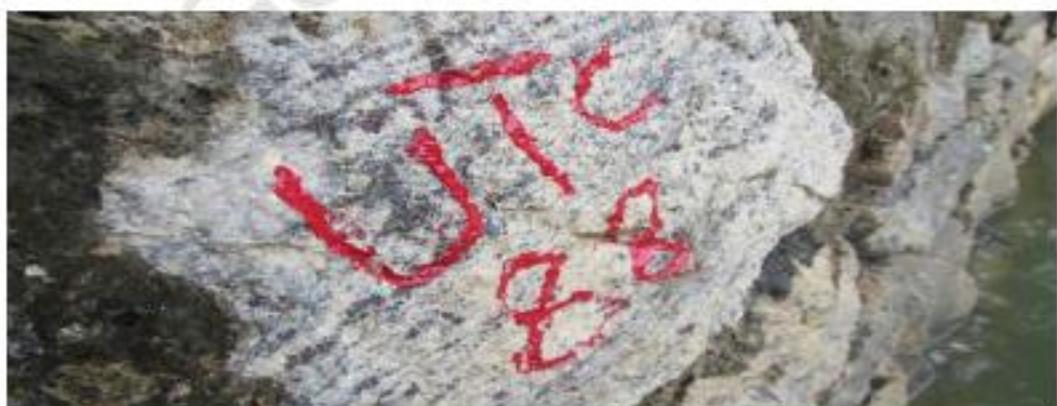
PROFILE - 88

The present profile falls at Vattamkadavu of Kulathoor Panchayat. The Bench mark is on the protection wall on the right bank of the river. It lies between $08^{\circ}19'52.6^{''}$ N latitude to $077^{\circ}04'53.9^{''}$ E longitude

TBM Protection constructed at Vattiam Kadavu on the right bank

BS	IS	FS	HI	RL	REMARKS	DISTANCE
1.51			101.51	100	RBP (BM)	0
	2.35			99.16	RBWL	2 m
	2.80 (5.15)			96.36	WD	17
	4.50 (6.85)			94.66	WD	12
	5.30 (7.65)			93.86	WD	17
	5.30 (7.65)			93.86	WD	22
	5.10 (7.45)			94.06	WD	27
	4.70 (7.05)			94.46	WD	32
	4.70 (7.05)			94.46	WD	37
	2.80 (5.15)			96.16	WD	42
		2.35		99.16	RBP	17

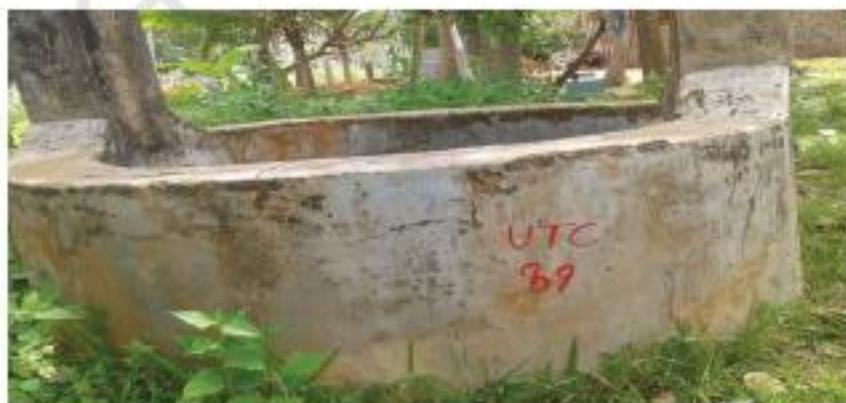
It falls at the Poovar Panchayat. A well on the right bank of the river is taken as benchmark. It lies between $08^{\circ}19'43.7''$ N latitude and $077^{\circ}04'50.7''$ E longitude

PROFILE-89
POOVAR GRAMA PANCHAYAT
TBM: Parapet of a well on the right bank

BS	IS	FS	HI	RL	REMARKS	DISTANCE
1.75			101.75	100	LBP (BM)	0
	2.6			99.15	LBWL	2 m
	3.30 (5.9)			95.85	WD	7
	4.60 (7.2)			94.55	WD	12
	4.80 (7.4)			94.55	WD	17
	5.70 (8.3)			94.35	WD	22
	5.90 (8.5)			93.45	WD	27
	5.30 (8.1)			93.25	WD	22
	3.30 (5.9)			93.65	WD	37
	1.40 (4)			97.75	WD	42
	.80 (3.4)			98.35	WD	47
		2.6		99.15	RBWL	52

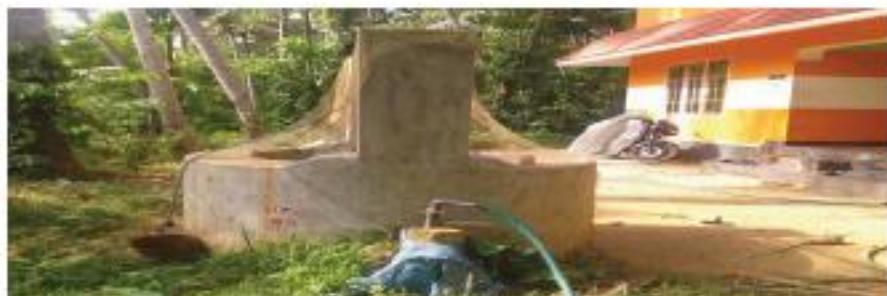
This profile falls at the Arumanoor ward of Poovar Panchayat. A house (House No 72) in the right bank is taken as benchmark. It lies between $08^{\circ}19'32.6^{''}$ N latitude and $077^{\circ}04'47.6^{''}$ E longitude.

PROFILE -90
POOVAR GRAMA PANCHAYAT
TBM: Parapet of well on the right bank

BS	IS	FS	HI	RL	REMARKS	DISTANCE
1.65			101.605	100	RBP (BM)	0
	1.79			99.815	RBP	15
	1.68			99.925	RBP	30
	1.66			99.945	RBP	45
	2.26			99.345	RBWL	54
	5.10 (7.36)			94.245	WD	59
	6.60 (8.86)			92.745	WD	64
	6.80 (9.06)			92.545	WD	69
	7.10 (9.36)			92.245	WD	74
	6.30 (8.56)			93.045	WD	79
	4.50 (6.76)			94.845	WD	84
	2.10 (4.36)			7.245	WD	89
	2.26			99.945	LBWL	99
		1.69		99.915	LBP	100
